# Asbestos Register and Management Review

| Site | Elmhurst Community Centre, Kettering |

| Project | Elmhurst Community Centre, Kettering: asbestos register annual review (completed example) |

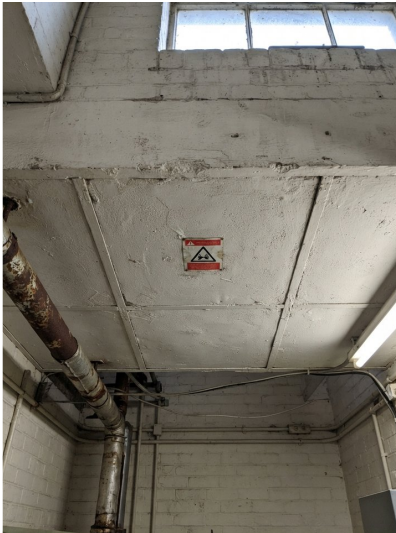
| Exact location and item reference | Boiler room, ceiling panels above the boiler, item ref A03 |

| Material description, extent and accessibility | Insulating board ceiling panels, about 6 m <sup>2</sup> , above head height. |

| Condition observation and observation date | Painted and intact, one corner chipped where a cable was fixed. Seen 2026-09-17. |

| Management controls and restrictions | Room locked, warning label on the door. No fixing to the ceiling. Chipped corner to be assessed by a licensed contractor. |

| Action and evidence reference | Licensed contractor to assess the chipped corner of the boiler room ceiling panel A03. |
