## SITE SURVEY REPORT

# Asset Inspection

| Project | Riverside Business Centre, Nottingham: quarterly asset round (completed example) |
| Report reference | AIR-2026-Q3-07 |

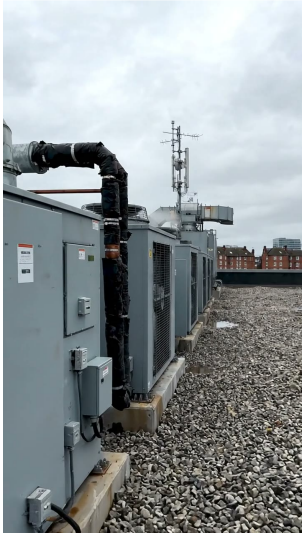
| Asset tag or ID | CON-01 |

| Coil and fins | Clean |

| Condition at this inspection | Good |

| Notes | Running at the time. No unusual noise. |

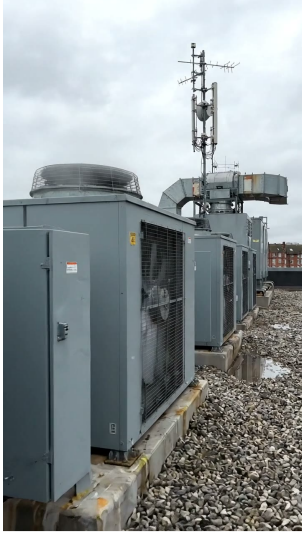
| Asset tag or ID | CON-03 |

| Coil and fins | Dirty |
| Condition at this inspection | Fair |
| Defect found | Coil fins dirty, leaf and pollen build-up across the face. Air off running warmer than CON-01. |

| Priority of the work | Soon, before the next visit |
| Who will put it right, and by when? | Coolair Services, coil wash at the October service visit (by 2026-10-16) |

| Notes | Coil wash added to the October service. |

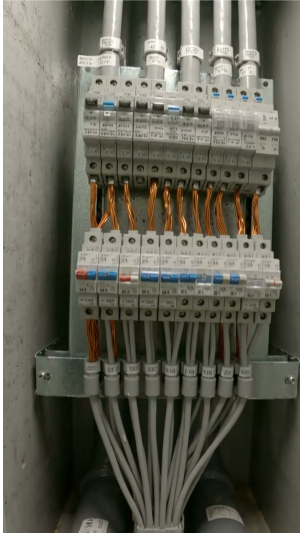
| Asset tag or ID | DB2 |

| Condition at this inspection | Poor |

Inner cover missing. Breakers and wiring are exposed as soon as the riser door is opened. Was in place at the June round.

Urgent

R. Patel, site electrician, new inner cover fitted by 2026-09-29

Riser door locked, key returned to the facilities office until the cover is refitted. Electrician booked.

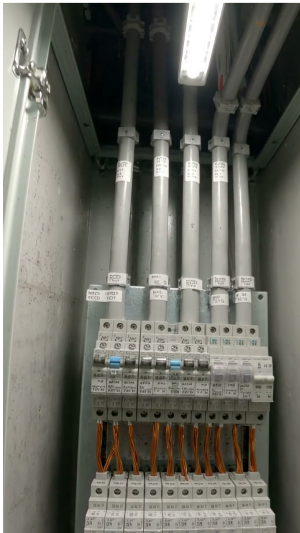
| What is different? | Register shows DB2 in riser 1. It is in riser 2. |

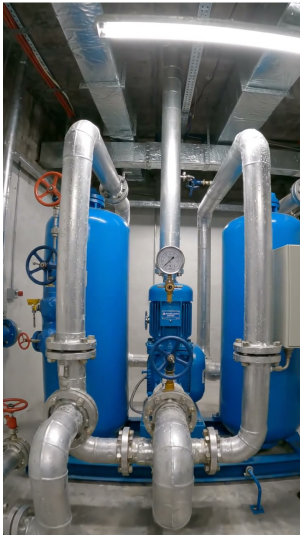
BST-01

| Condition at this inspection | Good |

| Notes | Duty and standby pumps both ran when changed over at the panel. |
