## SITE SURVEY REPORT

# Asset Register Survey

| Project | Hollins Park College, Derby: Block B asset register update (completed example) |
| Survey reference | ARS-0931 |

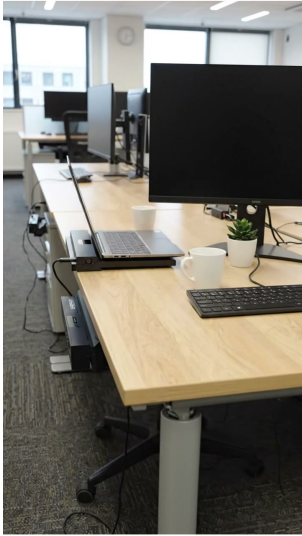
| What is it? | Bench desk with 24 inch monitor and USB-C dock |
| Room and position | Staff workroom B12, two banks of six |
| Condition | A, good |

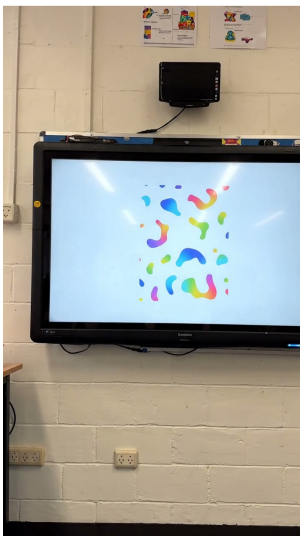
| What is it? | Interactive display, 75 inch, wall mounted, with soundbar |

B, satisfactory

| What deterioration or defect can you see? | Light scratches on the glass along the lower edge. Pen tray loose on one side. |

| What needs doing? | Refix the pen tray at the next visit. Budget to replace the display around 2030. |
| Priority | 3, desirable: 3 to 5 years |

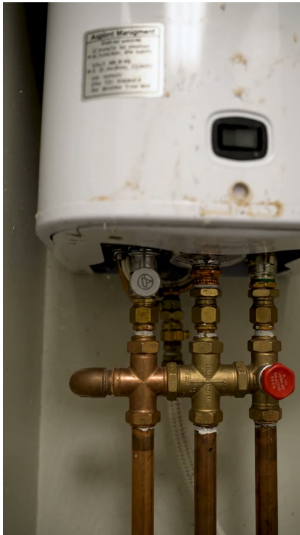
## Photos of the defect

| Condition | C, poor |
| What deterioration or defect can you see? | Rust staining down the casing below the data plate and around the controls.<br>No drip seen at the fittings below. |

| What needs doing? | Plumber to check for a slow leak above or inside the heater before the next service. |
| Priority | 1, urgent: immediate or within 1 year |

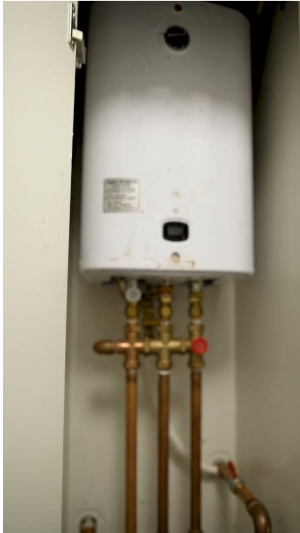
| What is it? | Unvented water heater, 30 litre, wall hung |
| Make and model | ExampleCo Heating UV30 |

Not on the 2025 register. Service sticker dated March 2026.
