# Balcony Condition Inspection

| Project | Marlowe Court, Canterbury: balcony condition inspection (completed example) |

| Building, elevation, floor and balcony ID | Marlowe Court, south elevation, floors 1 to 4, balconies S1-01 to S4-04 |

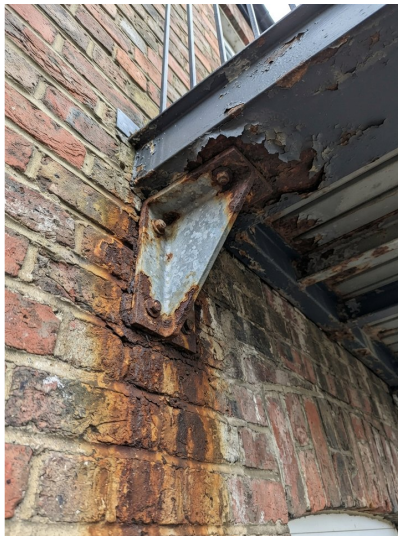
| Precise location | S2-03, underside, left hand wall bracket |

| Action, limitation or reason not applicable | Rust staining and flaking paint at the wall bracket under balcony S2-03. Extent of corrosion could not be judged from a visual check. |

| Observation and extent | Rust staining down the wall and flaking paint around the bracket fixing, about 200 mm across. |

| Restriction and specialist referral | Referred to a structural engineer for a close inspection. No restriction on use in the meantime as no distortion or movement was seen. |

Structural engineer to inspect the S2-03 wall bracket close up. Job SVH-26-2044.

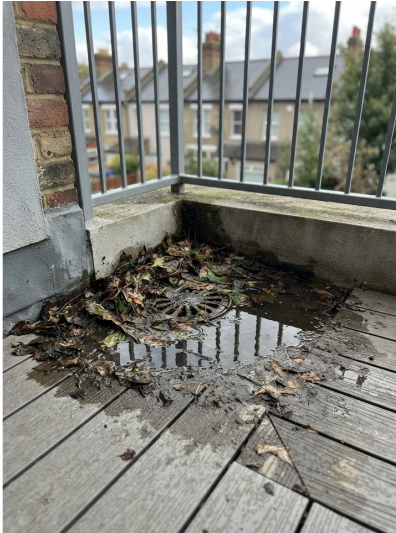
| Precise location | S1-02, drainage outlet at the front edge |

| Action, limitation or reason not applicable | Outlet blocked on S1-02, standing water about 10 mm deep across a third of the deck. |

| Observation and extent | Outlet blocked with leaves and soil, standing water on the deck. |

Cleared by hand on the day with the resident's agreement. Recheck after heavy rain.
