# Building Survey

| Project | 8 Ashwood Villas, Headingley, Leeds: building survey |
| Report reference | BS-2026-0207 |
| Property address | 8 Ashwood Villas, Headingley, Leeds LS6 3HT |

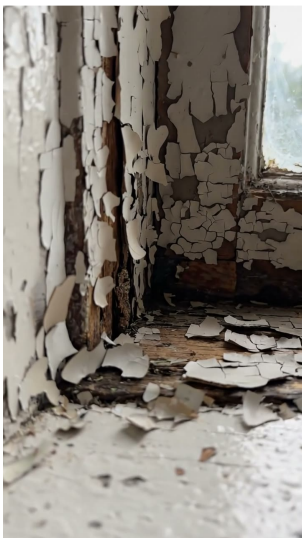
#### Photos of the window defects

| Defects found | Failed paint, Rot, Broken sash cords |

| Where is the rot? Give the window and the part of the frame | Rear bedroom, bottom rail of the lower sash and the inside lining |

| What did the probe find? | Soft at the surface only |

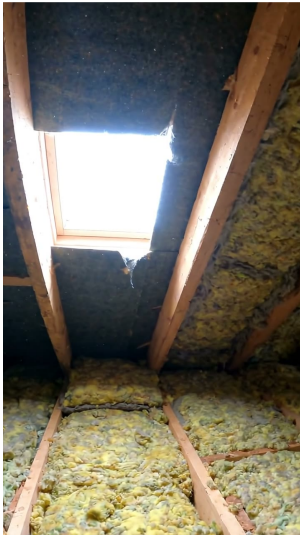
## Photos of the roof space

The insulation is below the recommended depth of 270 mm.

| Is daylight visible through the roof covering or felt? | Yes |

| Where? | Rear slope, through torn felt beside the chimney stack |

| Signs seen on the roof timbers | Staining |

Old water staining on two rafters below the torn felt. Dry on the day and sound when probed.

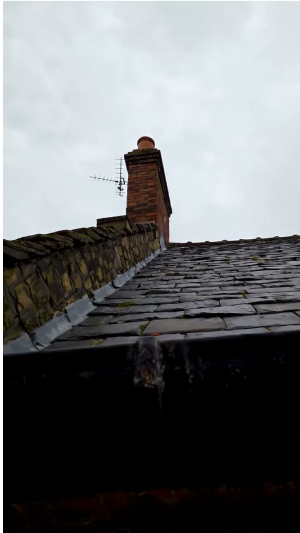
### Elements 1: D2 Roof coverings

| Which part, and where? | Rear slope beside the chimney |
| Condition rating | 3 |
| Defect found | Slipped slates beside the chimney and torn felt below them. Daylight visible from the roof space. |
| Most probable cause | Age of the covering, with fixings failing |
| What is likely to happen if it is not repaired? | Rain will get into the roof space and damage the timbers and the bedroom ceiling below |

| Repair recommended | Roofer to refix slipped slates, renew the felt locally and check the chimney flashing |

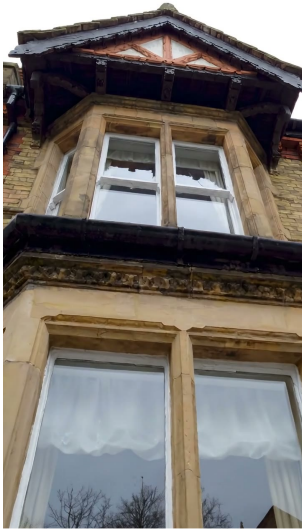
## Elements 2: D3 Rainwater pipes and gutters

| Which part, and where? | Front gutter above the bay |
| Condition rating | 2 |
| Defect found | Gutter sagging above the bay, joint dripping |
| Most probable cause | Brackets corroded |

| Repair recommended | Refix on new brackets, reseal the joint and repaint |

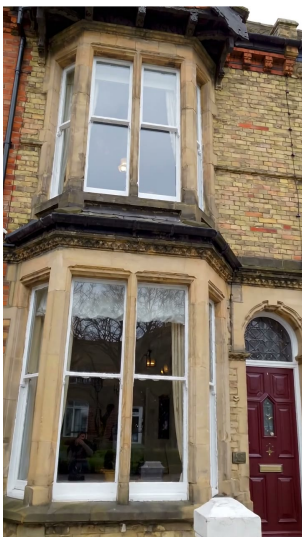
## Elements 3: D4 Main walls

| Which part, and where? | Front elevation |
| Construction and materials | Solid red brick with stone bay and dressings. Pointing fair, no cracking seen. |
| Condition rating | 1 |

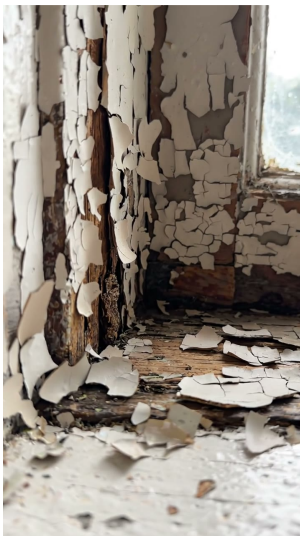
## Elements 4: D5 Windows

| Which part, and where? | All windows, worst at the rear bedroom |
| Condition rating | 2 |

| Defect found | Paint failing, rot starting in the bottom rails, three sash cords broken |
| Most probable cause | Lack of regular painting |

| Repair recommended | Overhaul all sashes: cut out and splice soft timber, renew cords, prepare and repaint |

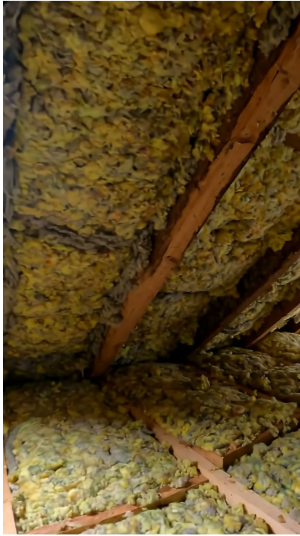
#### Elements 5: E1 Roof structure

| Construction and materials | Cut timber rafters and purlins. No sagging or splitting seen. |
| Condition rating | 1 |
