# CCTV Drain Survey Record

| Date | 26 Sep 2026 |
| Site | 12 Orchard Rise, Taunton |

| Project | 12 Orchard Rise, Taunton: CCTV drain survey (completed example) |

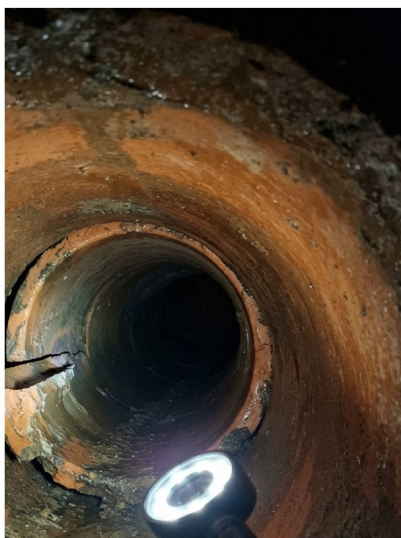
#### Observation 1: R1

| Chainage, unit and video time reference | 3.2 m, video 01:48 |
| Observed defect and extent | Displaced joint, pipe end dropped by about 15 mm. Small build-up of fat downstream. |

| Cleaning, further survey or specialist review recommendations | Root cut and jet R2, then survey the rest of R2 from IC3. Displaced joint on R1 to be considered for a patch repair after the full survey. |

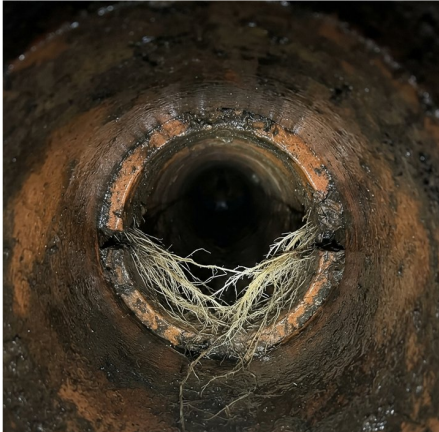
**Observation 2: R2**

| Obstruction, water level, visibility and unsurveyed extent | Camera could not pass roots at 4.1 m. Remaining 4.9 m not surveyed, to be surveyed upstream from IC3 after cutting. |

| Chainage, unit and video time reference | 4.1 m, video 02:35 |
| Observed defect and extent | Fine roots through the joint, about half the pipe bore blocked. Survey abandoned here. |

| Action and evidence reference | Root cut and jet R2, then survey the remaining 4.9 m from IC3. |
