## SITE SURVEY REPORT

# Chiller Maintenance

| Site | Westgate Business Centre, Cardiff |

| Project | Westgate Business Centre, Cardiff: chiller quarterly maintenance (completed example) |

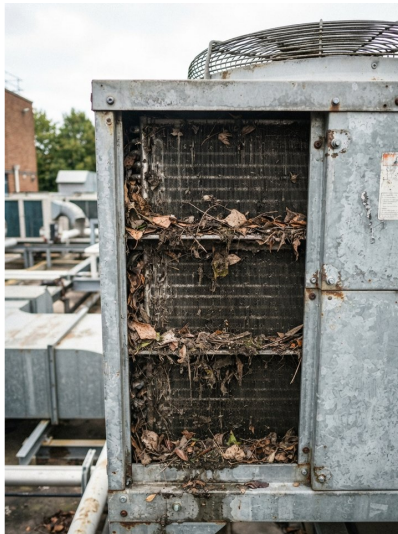
**Condition and work evidence photos**

| Action, limitation or reason not applicable | Condenser coils on circuit 2 partly blocked with leaves and debris. Cleaned with a soft brush and low pressure water. |
| Action, limitation or reason not applicable | Strainer on the chilled water return partly blocked with debris. Cleaned, likely cause of the low flow alarm. |

| Work performed and parts used | Cleaned condenser coils on circuit 2 and the chilled water strainer. New strainer basket gasket fitted. |
