# Coating and Corrosion Inspection

| Project | Unit 7, Riverside Trade Park, Grimsby: coating inspection (completed example) |
| Company | Eastfield Coatings Inspection Ltd |
| Structure or area (building, frame, bay) | Warehouse portal frame, bays 1 to 6, gridlines A to F |

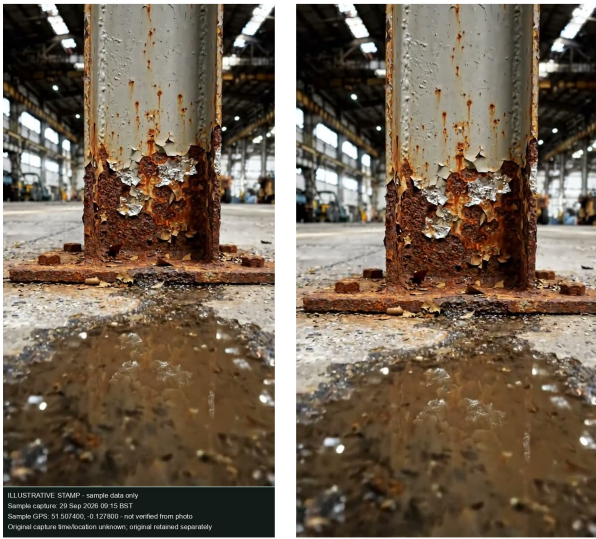
### Areas 1: Column B3

| Coating and corrosion seen | Rust staining, Pitting or loss of steel |
| Extent | Local area |
| Where on the member | Base or ground contact, Water or dirt trap |
| Length of the affected patch (m) | 0.45 |
| Width of the affected patch (m) | 0.30 |
| Dry film thickness reading (microns), if measured | 95 |
| Against the specification | Below the specified minimum |
| Visible loss of steel section? | Yes |

Visible loss of steel section. Refer it to a structural engineer before the coating is repaired.

| Priority | Refer to a structural engineer |

#### Further actions 1: Structural engineer to assess the base of column B3 before any repair.

#### Further actions 3: Check the downpipe discharge near B3 that keeps the column base wet.

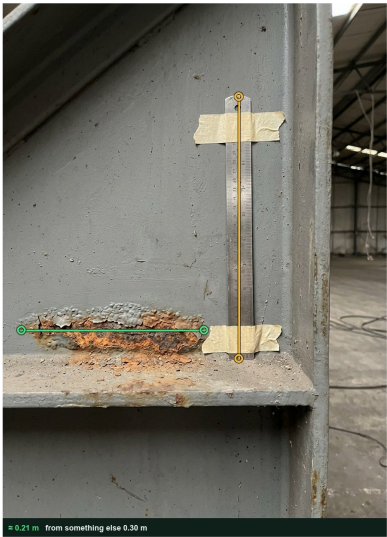
Length of the affected patch (m): measuring photo

| Length of the affected patch (m) | 0.21 |

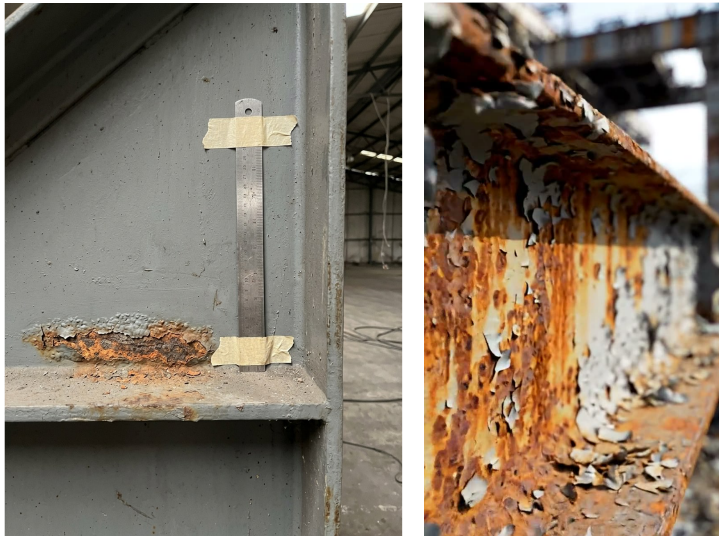
Areas 2: Beam B3 to C3, bottom flange

| Coating and corrosion seen | Blistering, Flaking or peeling, Rust spots |
| Extent | Local area |
| Where on the member | Flat surfaces, Edges and corners |

| Width of the affected patch (m) | 0.06 |
| Dry film thickness reading (microns), if measured | 140 |
| Against the specification | Below the specified minimum |
| Visible loss of steel section? | No |
| Priority | Coating repair |

#### Further actions 2: Prepare and patch coat the bottom flange of beam B3 to C3 to the original specification.

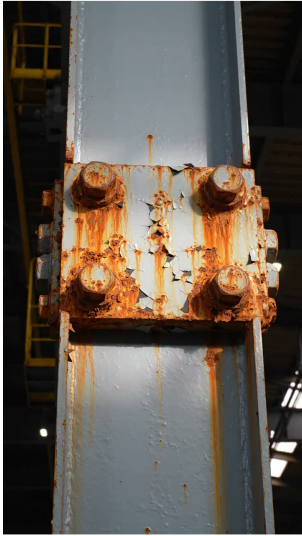
## Areas 3: Connection C4 (beam to column)

| Coating and corrosion seen | Rust staining |
| Extent | Isolated spots |
| Where on the member | Bolts and connections |
| Visible loss of steel section? | No |
| Priority | Monitor |

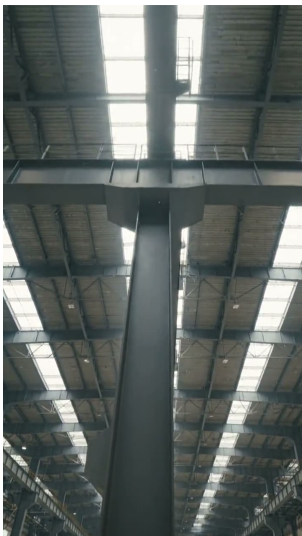
## Areas 4: Columns D1 to F6

| Coating and corrosion seen | None seen |
| Dry film thickness reading (microns), if measured | 210 |
| Against the specification | At or above |
| Visible loss of steel section? | No |
| Priority | No action |
