# Conveyor Belt Inspection

| Project | Kingsmead Fulfilment Centre: conveyor C4 inspection (completed example) |
| Inspection date | 5 Oct 2026 |
| Conveyor reference | C4 outbound sortation belt |

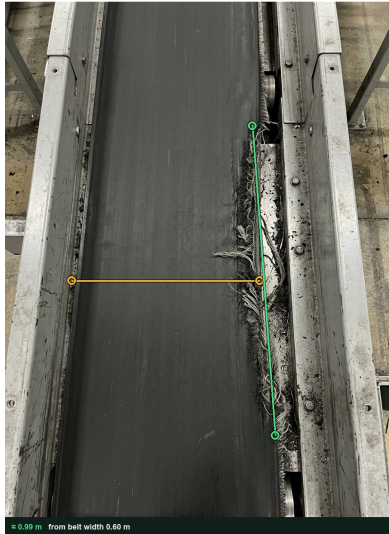
Length of the worst belt damage (m): measuring photo

| Belt edges: no fraying | Defect |
| What is wrong? | Belt edge frayed over about 1.0 m where it rubs the frame near roller 18. Measured from a photo against the 0.6 m belt width. |

Length of the worst belt damage (m) 0.99

| What needs doing? | Trim and monitor the frayed edge, quote for a new belt if it spreads. |
