# Crane Pre-use Inspection

| Project | Fairfield Road Retail Park, Aylesbury: steel frame erection |

| Crane asset ID and location | Crawler crane CC-08, set up on the matting at grid line 4 to 5 |

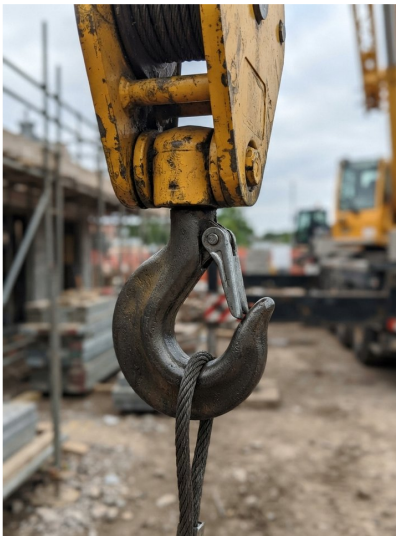
| Action, limitation or reason not applicable | Hook safety catch spring weak on the main hook, catch does not close fully on its own. Crane not used for lifting until fixed. |

| Defects, restrictions and action taken | Hook safety catch spring weak. Fitter replaced the spring at 08:40 and the catch now closes on its own. Re-checked by the operator before the first lift. |

| Completion evidence | Spring replaced at 08:40, catch closes on its own. Logged in the crane defect book, entry 112. |
