# Damp and Mould Inspection

| Project | Flat 6, Ashdown Court, Leeds: damp and mould inspection |
| Report reference | DM-2026-0418 |
| Property address | Flat 6, Ashdown Court, Fernbank Road, Leeds LS9 7QT |

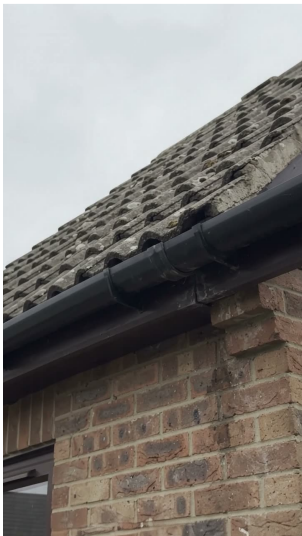
Photos of the defects

| Describe the defects and where they are | Gutter joint dripping at the rear, above the stairwell window. It is two bays away from flat 6 and not above the affected rooms. |

| Where are the defects outside? | Rear gutter joint, above the stairwell · 53.804120, -1.512360 (SE 32212 34312, ±7 m) |

| Other causes ruled out, and how | No leak: pipework under the bath and basin dry, no staining from the roof above. The dripping gutter joint at the rear is above the stairwell, not flat 6, and the wall inside is dry there. Readings fall away from the cold corner, which fits condensation rather than water getting in. |

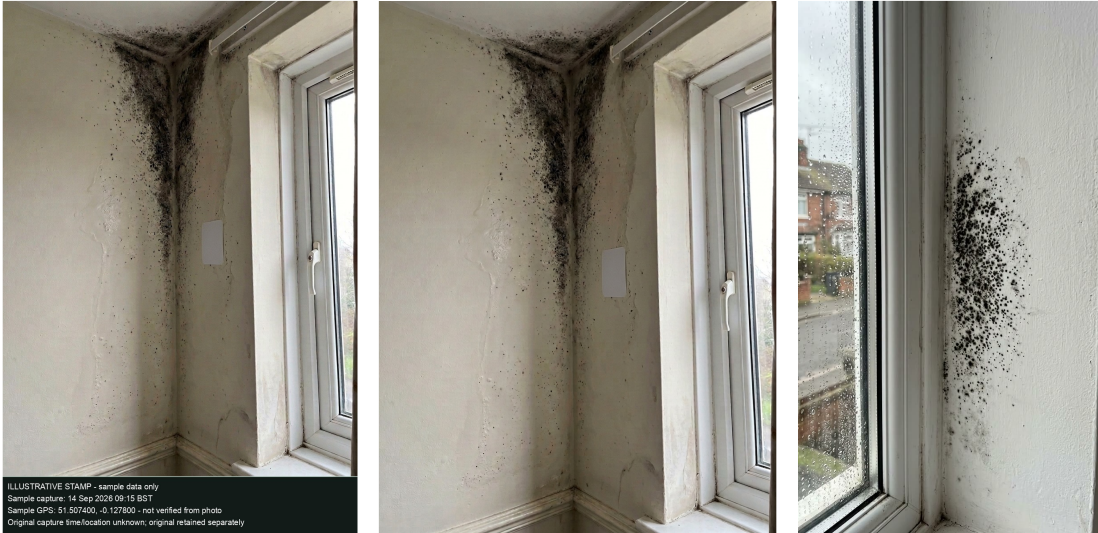
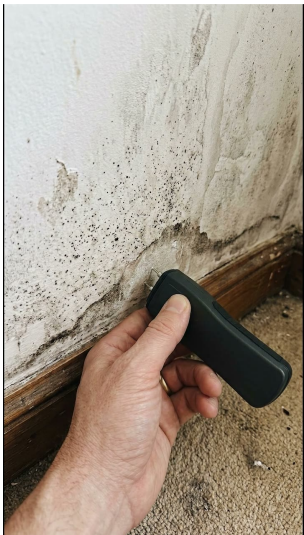
Photos of the damp or mould

| Rooms affected 1: Bedroom | |
|---|---|
| Which one, and where in the room? | Back bedroom, children's room. Ceiling corner and window reveal on the external wall. |
| Which looks most like what you can see? | Spotting in a ceiling corner |

Black mould spreading out of the ceiling corner and down the wall beside the window, about 1.57 m high, measured from a photo with an A4 sheet taped to the wall, and 0.9 m wide across both walls with a tape. Worst beside the window reveal. Low level staining above the skirting on the same wall. Bunk beds against this wall.

| What is causing the condensation? | Extractor fan missing or not working, Background ventilation blocked or missing, Cold surface or missing insulation |

| Reason for the decision | Mould on the external wall and ceiling corner of the back bedroom, around 13% of that wall, and spreading. The room scores 8 of 9 on the form's severity guide: wide spread, readings at the dew point, a wet reading twice the dry wall, and a child with asthma sleeps in it. The bathroom fan has not worked since July, so moisture has no way out. A reasonable landlord would make this safe as a matter of urgency, but not within 24 hours. |

| Safety work | Clean and treat the mould, Repair or replace the extractor fan, Clear or reinstate the vents |

| Work to stop it coming back | Fit a ducted cooker hood in the kitchen. Survey the cavity and ceiling insulation at the bedroom corner and top up where it is missing. |

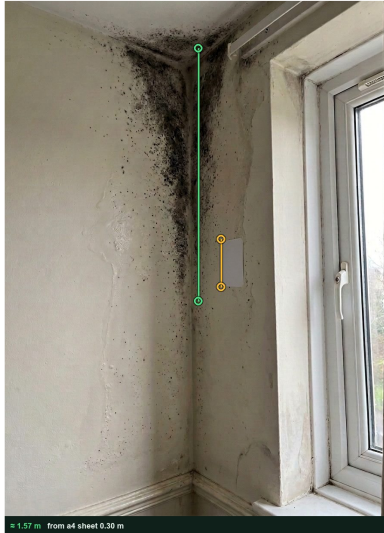
## Height of the patch (m): measuring photo

| Width of the patch (m) | 0.9 |
| Height of the patch (m) | 1.57 |

| Area of the patch (m <sup>2</sup> ) | 1.41 |

| Share of the surface affected (%) | 13 |

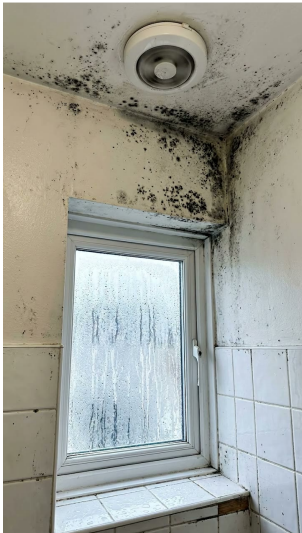
## Photos of the damp or mould

| Which one, and where in the room? | Ceiling around the extractor fan and above the window |
| Which looks most like what you can see? | Growth across a bathroom ceiling |

| What you can see | Mould across the ceiling corner around the fan and above the window.<br>Heavy condensation on the glass at the time of the visit, shower used about an hour earlier. |

| What is wrong with it? | Fan does not run with the light switch or the pull cord. Motor seized. |

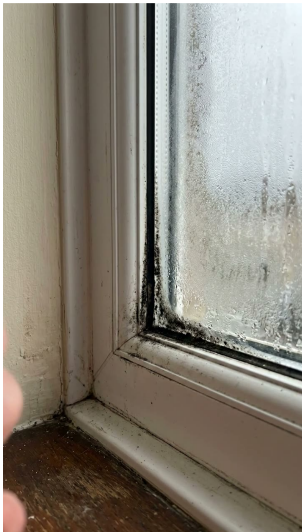
#### Photos of the damp or mould

| Which one, and where in the room? | Window reveal on the front wall, left hand side |
| Which looks most like what you can see? | Spotting beside a window |

| What you can see | Light spotting on the sealant and the reveal at the bottom of the window. Wiped off easily. Trickle vent on this window was shut. |

**Anything done on the visit** Opened and cleaned the trickle vents in both bedrooms. Gave the resident a dehumidifier on loan and advice on drying washing.
