# Decking Inspection

| Date | 2 Oct 2026 |
| Site | 5 Orchard Rise, Shrewsbury |
| Prepared by | K. Mills |

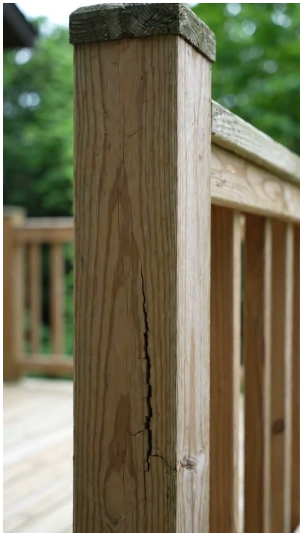
**Defects 1: Cracked balustrade corner post, loose**

| <b>What is wrong?</b> | Corner post cracked near its base and moves when pushed |
| <b>Guarding height against 1100 mm (Approved Document K, for reference)</b> | Below 1100 mm |

The guarding is lower than the 1100 mm Approved Document K gives for external balconies in single family dwellings. For an existing deck this is a reference, not a requirement: record it and say whether a higher rail is recommended.

| Defect | Cracked balustrade corner post, loose |
| Location | North-east corner |
| Length of the damage (m) | 0.45 |
| Risk | Make safe now |
| Made safe on site (taped off or closed)? | Yes |

Replace the corner balustrade post and refix the rails.

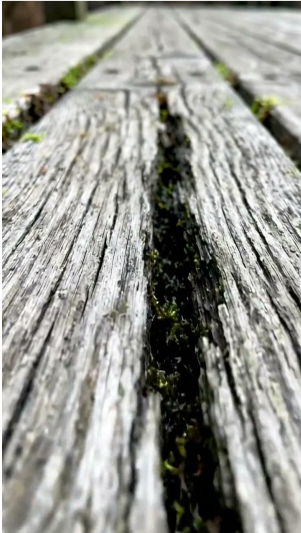
**Defects 2: Split and soft deck board**

| <b>What is wrong?</b> | Third board from the house split along its length and soft at one end |

| Defect | Split and soft deck board |
| Location | Third board from the house |
| Length of the damage (m) | 1.20 |
| Risk | Repair soon |

Replace the split board and reset the raised screws.

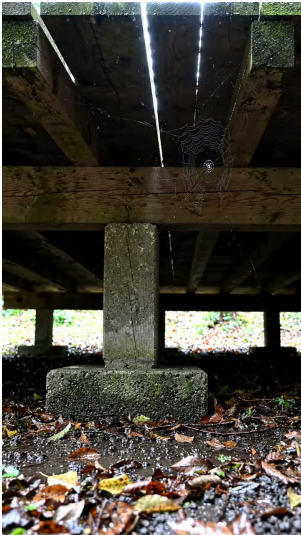
Defects 3: Algae on the boards, wet leaves under the deck

| <b>What is wrong?</b> | Green algae on the boards in the shaded corner, slippery when wet |

| Defect | Algae on the boards, wet leaves under the deck |
| Location | Shaded corner by the fence |
| Risk | Monitor |

Ask the tenant to keep the deck brushed clear of algae.
