# Electrical Preventive Maintenance Checklist

| Date | 20 Oct 2026 |
| Site | Kingsmead House, Slough |

| Project | Kingsmead House, Slough: electrical planned maintenance (completed example) |

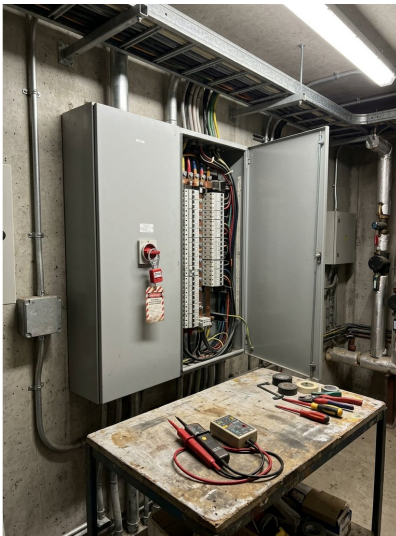
| Lockout record or permit reference | Lockout record LR-2026-118 (UPS-C1 input supply isolator) |

#### Photos of locks and notices

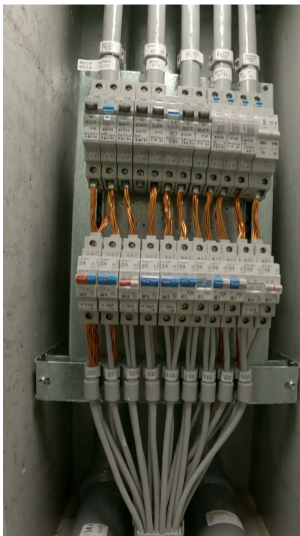
**Photos: equipment and rating plate**

| Equipment tag | DB-3A |

| What needs doing, or why not checked | Board energised; tenant outage not agreed for this visit. |
| What needs doing, or why not checked | Needs an outage. Will be done with the repair to way 4. |

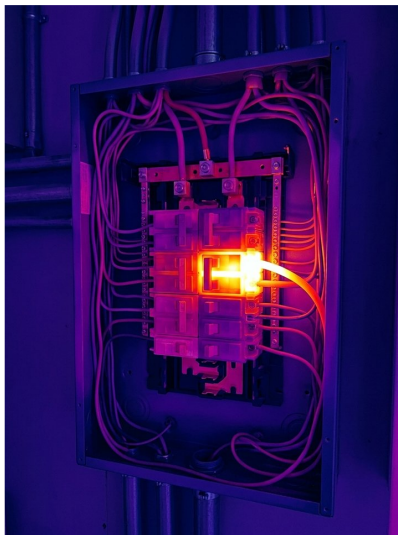
## Thermal image and matching photo

| Where is the hot spot? | Way 4 MCB, outgoing terminal (L2 phase) |
| Hottest temperature rise (°C) | 31 |
| Your acceptance figure for action (°C) | 10 |
| Load at the time (amps or %) | Way 4 at 14 A of 20 A |
| Thermography result | Above your acceptance figure |

Summary for the client Annual PPM on the main switchboard, riser board DB-3A and the comms room UPS. Thermography found a hot terminal on DB-3A way 4: 31 °C above the neighbouring ways at 14 A, against the 10 °C action figure in the client's specification. The repair needs a short outage on level 3 east and is booked within 7 days. Torque checks, internal cleaning and trip tests on MSB-1 and DB-3A are booked for the 8 November shutdown. The UPS was maintained on bypass with no defects.

HSE guidance on switchgear (HSG230) says that in most cases, if a hot component is found, the equipment should be isolated to make the repair.

Action DB-3A way 4: isolate, check the outgoing terminal and MCB, re-terminate or replace the MCB, then re-scan under load and send the client the new thermal image.

Priority Within 7 days

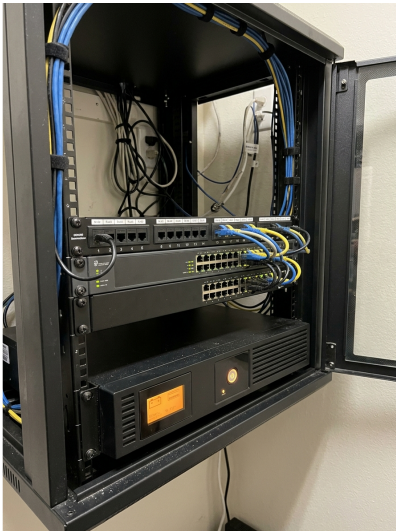
**Photos: equipment and rating plate**

| Equipment tag | UPS-C1 |

| UPS batteries: no swelling, leaks or corrosion; terminals secure | Acceptable |
