# Emergency Shower Inspection

| Site | Westmoor Water Treatment Works, Barnsley |

| Project | Westmoor Water Treatment Works, Barnsley: chemical dosing area |

| Station ID and location | ES-03, combined safety shower and eyewash, outside the sodium hypochlorite dosing room |

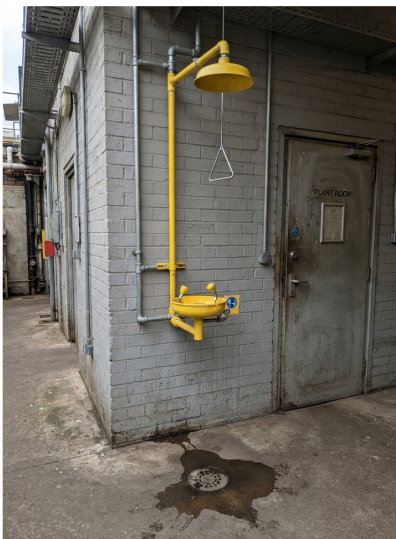
| Action, limitation or reason not applicable | Floor drain under the shower slow to clear. Water pooled for about two minutes after the test. |

| Outstanding limitations and information to pass on | Drain slow to clear. Shower and eyewash fully working. |

| Repair or follow-up job reference | Works order WO-WM-7714, clear floor drain under ES-03 |

| Action and evidence reference | Clear the floor drain under ES-03 and test the flow. |
