# Environmental Site Inspection

| Date | 30 Sep 2026 |
| Site | Millbeck Lane, Carlisle |

| Project | Millbeck Lane, Carlisle: environmental site inspection |

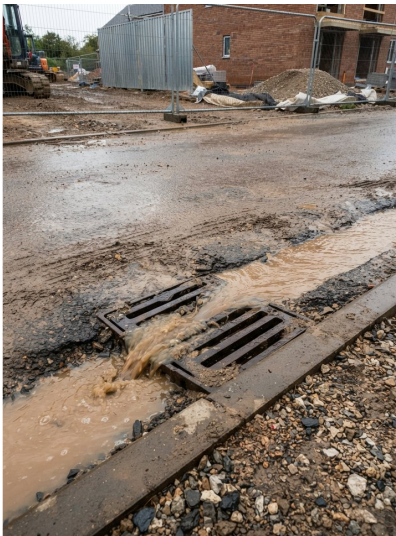
### Environmental observation 1: Site entrance, gully G3, during plot 6 dewatering

| Action, limitation or reason not applicable | Silty water pumped from the plot 6 excavation was running into road gully G3 at the site entrance. Gully uncovered. Pump stopped and discharge rerouted to the settlement tank. |

| Location and activity | Site entrance, gully G3, during plot 6 dewatering |
| Observation and potential receptor | Brown silty water entering the road gully. The gully drains to the surface water sewer and on to Millbeck, the nearest watercourse. |

| Immediate control and responsible person | Pump stopped, gully covered, discharge routed through the settlement tank. Groundworks foreman L. Nixon. |

| Action and evidence reference | Fit gully covers and silt socks at G3 and G4 while excavations are open. Photos to EI-MBL-007. |
| Completion evidence | Covers and silt socks fitted 1 October, photos added to EI-MBL-007. |
