# Excavation Inspection Report

| Site | Orchard Rise, Plot 12, Didcot |

| Project | Orchard Rise, Plot 12, Didcot: water connection pit |

| Excavation location and description | Service connection pit beside plot 12, about 1.8 m long, 0.9 m wide and 1.1 m deep. New water main and drain connection laid on gravel bedding. |

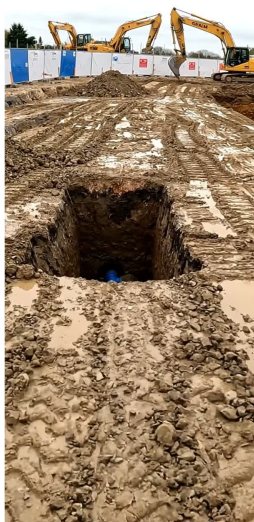
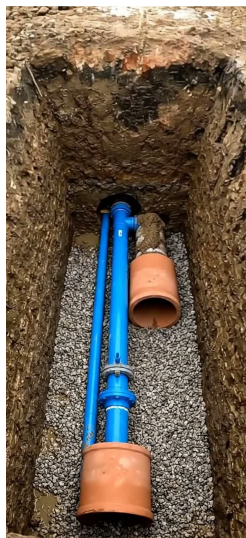
**Supporting photos**

| Action, limitation or reason not applicable | Spoil heap within a metre of the far end of the pit. Moved back before anyone works at the pit. |

| Action, limitation or reason not applicable | No barriers round the pit. Plant and people walking past. Barriers to go up before work starts. |

| Matters identified that could create risk | Open pit with no edge protection next to a haul route. Spoil close to the edge. Surface water ponding round the pit after overnight rain. |

| Action taken immediately | Pit closed off with barriers from the compound. Ground worker told not to enter until barriers are up and spoil moved. |
| Further action considered necessary | Keep the spoil back from the edge. Barriers to stay until the pit is backfilled. Re-inspect after heavy rain. |

| Action and evidence reference | Put barriers round the pit and move spoil back from the edge. |
