# Facility Inspection Checklist (Building Walk-round)

| Project | Kennet Place, Reading: monthly facility inspection (completed example) |
| Building address | Kennet Place, 40 Kings Meadow Road, Reading RG1 8EX |
| Inspection date | 20 Oct 2026 |

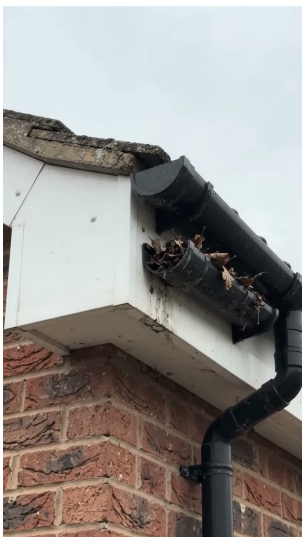
| What needs doing, or why not checked | Rainwater hopper above the main entrance blocked with leaves; water overflowing onto the entrance canopy. |

| What is wrong | Clear blocked rainwater hopper above the main entrance and check the downpipe runs freely. |

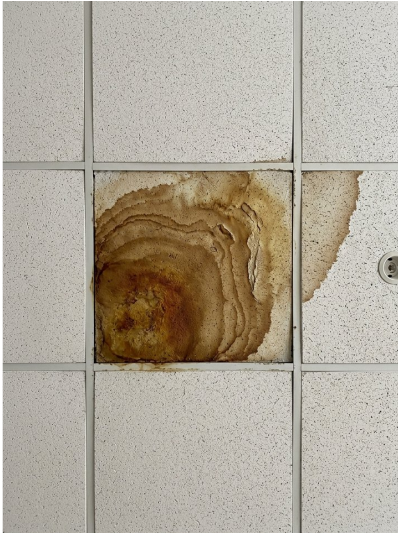
| What needs doing, or why not checked | Water stain on one ceiling tile by the east window, damp to the touch. Fan coil or pipework above suspected. |

| What is wrong | Find the leak above the stained ceiling tile, repair and replace the tile. |

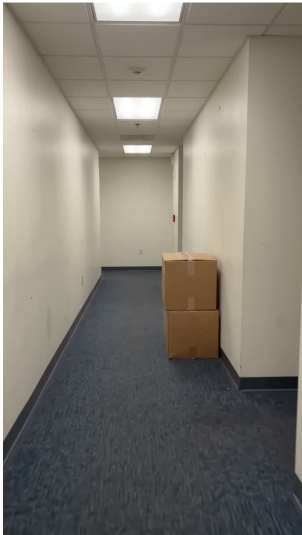
| What needs doing, or why not checked | Cardboard boxes stored in the escape corridor outside Tenant C. Asked tenant to remove today. |

| What is wrong | Boxes in the escape corridor. Tenant C to remove and keep the corridor clear. |

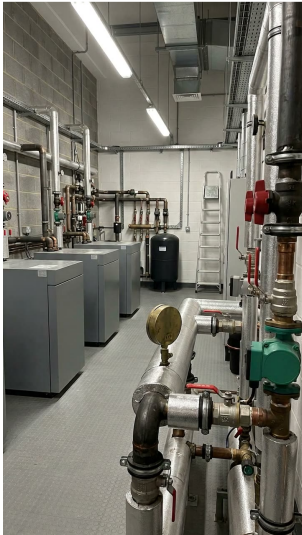
| Anything else found | Boilers and pumps running, no alarms on the BMS. No storage in the room. |
