# Fan Coil Maintenance Visit

| Site | Victoria Chambers, Leicester |

| Project | Victoria Chambers, Leicester: fan coil service, third floor (completed example) |

| Fan coil unit ID, model and location | FCU-3-07, four-pipe ceiling void fan coil, meeting room 3.04 |

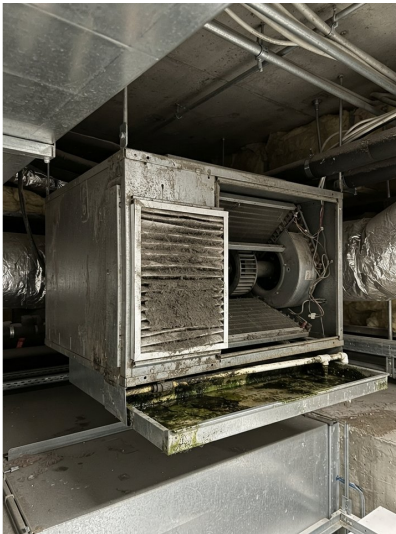
**Condition and defect evidence**

| Action, limitation or reason not applicable | Filter heavily loaded with dust. Replaced with new filter on this visit. |
| Action, limitation or reason not applicable | Slime in the condensate tray and drain slow. Tray cleaned and drain flushed through to the tundish, now running freely. |
| Action, limitation or reason not applicable | Heating valve actuator does not respond to a BMS heat demand. Valve stays closed. Cooling side responds correctly. |

| Cleaning, parts and adjustments recorded | Filter replaced, condensate tray cleaned, drain flushed. No adjustments to set points. |

| Exception and response | Heating valve actuator not driving. Actuator replacement raised, job MBS-26-2215. |
