# Fire Compartmentation Survey

| Project | Whitecross House: compartmentation survey (completed example) |
| Site address | Whitecross House, Bristol |
| Survey date | 13 Oct 2026 |

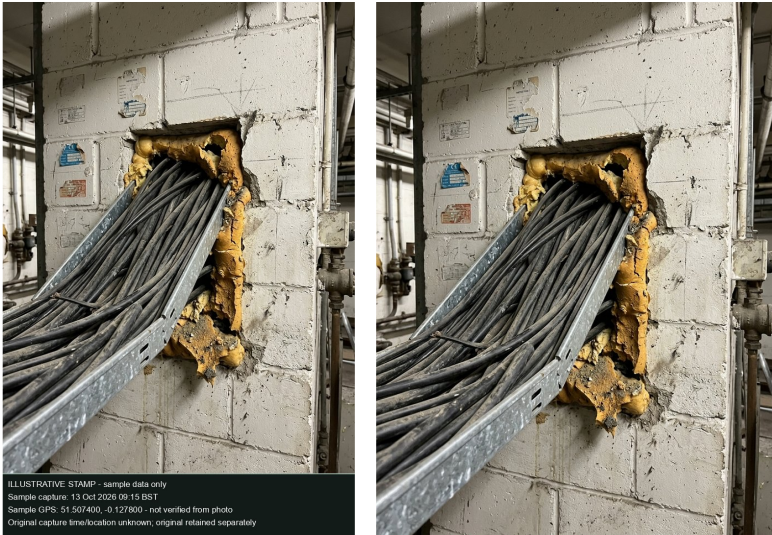
| Reference | C-03 |

| Room or location on this floor | Plant room wall to the bin store |
| Element | Compartment wall |
| Required fire resistance | 120 minutes |

| Defect | Failed or poor fire-stopping |
| Services through it | Cable tray |
| Opening width (mm) | 300 |
| Opening height (mm) | 180 |
| Existing product or label, if any | Expanding foam (unlabelled), cracked and shrunk |
| Priority | High: fix now |

| Recommended remedy | Remove the foam and fit a batt and coating system tested for cable trays in a 120 minute wall. |

| What needs doing? | Fire-stopping contractor to fix C-01 and C-03. |

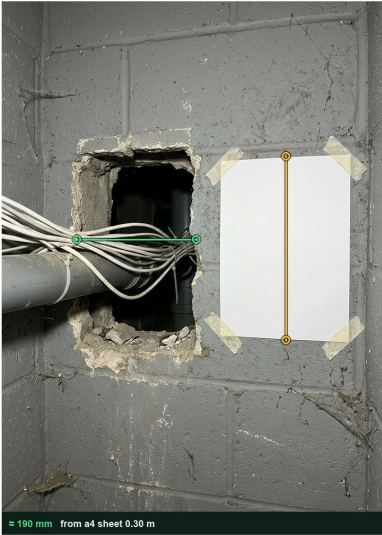
Opening width (mm): measuring photo

| Opening width (mm) | 190 |

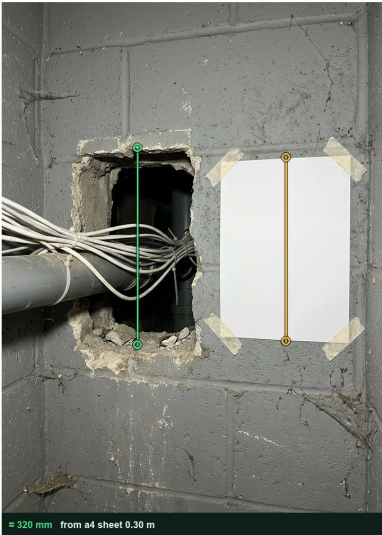
Opening height (mm): measuring photo

| Opening height (mm) | 320 |

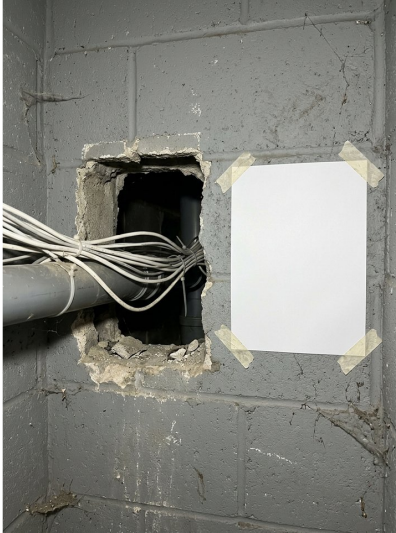
| Reference | C-01 |

| Room or location on this floor | Riser cupboard by flat 2.03 |
| Element | Riser or shaft |
| Required fire resistance | 60 minutes |
| Defect | Unsealed service penetration |
| Services through it | Plastic pipe, Cables |

| Priority | High: fix now |

| Recommended remedy | Intumescent pipe collar on the soil pipe and a tested sealant or batt system around the cables. |

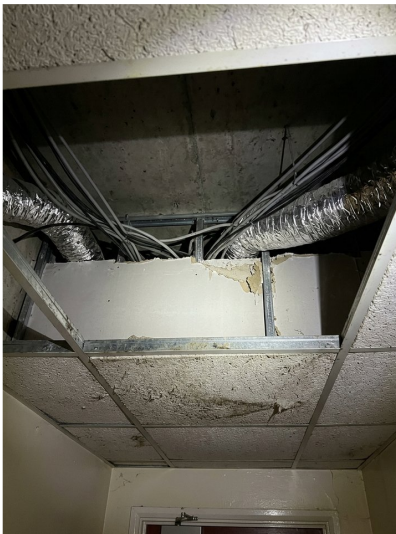
| Reference | C-02 |

| Room or location on this floor | Corridor ceiling void outside flats 4.01 to 4.04 |
| Element | Cavity barrier |
| Required fire resistance | 30 minutes |
| Defect | Missing cavity barrier |
| Services through it | Ductwork, Cables |
| Opening width (mm) | 1200 |
| Opening height (mm) | 450 |
| Opening area (m <sup>2</sup> ) | 0.54 |
| Priority | Medium |

| Recommended remedy | Install a cavity barrier above the corridor partition, sealed around the duct and cables. |

| What needs doing? | Cavity barrier at C-02 and seal C-04. |
