# Fire Hydrant Inspection

| Site | Brackenfield Business Park, Chesterfield |

| Project | Brackenfield Business Park, Chesterfield: private hydrant H3 check (completed example) |

| Hydrant ID, type and exact location | H3, private underground hydrant on the estate ring main, verge opposite Unit 8 |

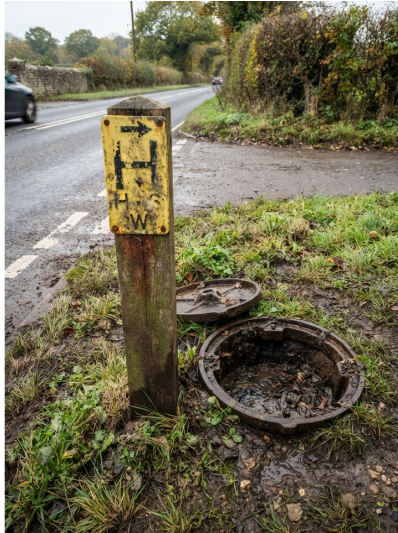
| Action, limitation or reason not applicable | Indicator plate on the post is faded and the H and size markings are hard to read from the road. Post upright and secure. |

| Action, limitation or reason not applicable | Cover lifted with a key, frame sound. Chamber about one third full of silt and leaves. Outlet visible but cap not checked closely. |

| Defects, service impairment and temporary arrangements | No service impairment found within this visual check. Silt in the chamber could slow connection in an emergency. |

| Action and evidence reference | Replace the faded hydrant indicator plate on the post at H3. |

| Action and evidence reference | Clear silt and leaves from the H3 chamber and check the outlet cap. |
