SITE SURVEY REPORT

# Foundation Crack and Settlement Inspection

| Date | 14 Oct 2026 |
| Site | 12 Larkspur Crescent, Bexleyheath |

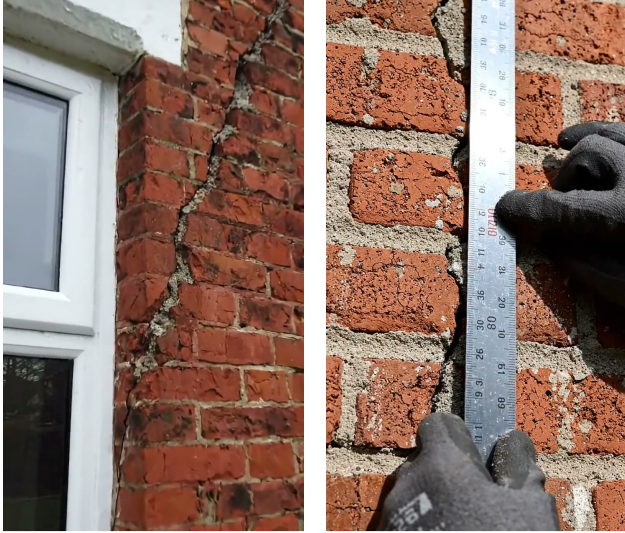
| Crack reference | C1 |

| Where on this elevation | Above the ground floor bay window, right-hand corner |
| Orientation | Stepped (through the mortar joints) |
| Runs through | Mortar joints only |
| Widest width (mm) | 4 |
| Length (m) | 1.1 |
| Tapering | Wider at the top |
| Appearance | Previously filled and reopened |
| BRE Digest 251 category, if the inspector assessed it | Category 2 |

| Monitor ID and first reading | Tell-tale TT1 fitted 14 Oct, reading 0.0 mm horizontal, 0.0 mm vertical |

| Inspector's view | Stepped cracking above the front bay, tapering wider at the top and reopening the 2019 repointing, with the bay door catching and the floor falling towards the bay. The pattern is consistent with movement of the bay relative to the main house. Shrinkable clay and a mature oak 9.5 m away are noted, but the cause has not been established. Monitoring over the coming months will show whether the crack is opening and closing with the seasons or progressing. |

| Suggested monitoring period | Monthly readings of TT1 and C1 for 12 months |

| Action | Read tell-tale TT1 and gauge C1 monthly; record on the crack monitoring record. |

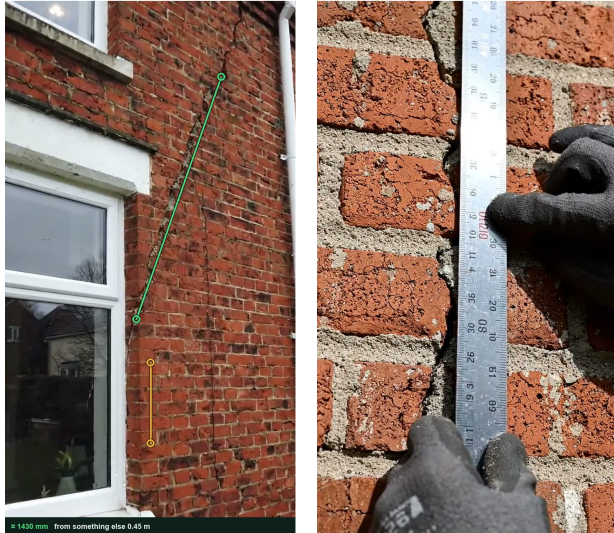
| Crack reference | C3 |

| Where on this elevation | From the top corner of the first floor bedroom window |

| Orientation | Diagonal |

| Runs through | Mortar joints only |

| Widest width (mm) | 1.5 |

| Length (m) | 0.8 |

| Tapering | Wider at the top |

| Appearance | Dirty, old or painted over |

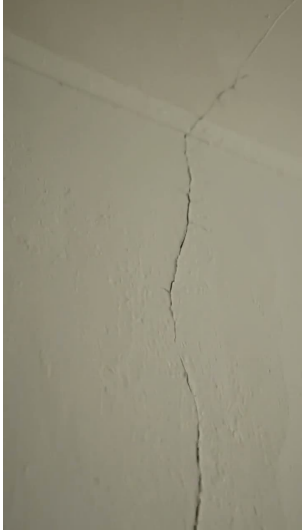
| Crack reference | IC1 |

| Where | Around a door or window opening |
| Orientation | Diagonal |
| Widest width (mm) | 2 |

| Length (m) | 0.6 |
| Tapering | Wider at the top |

| Other signs in this room | Door to the hall catches at the head on the latch side. Plaster crack lines up with C1 outside. |

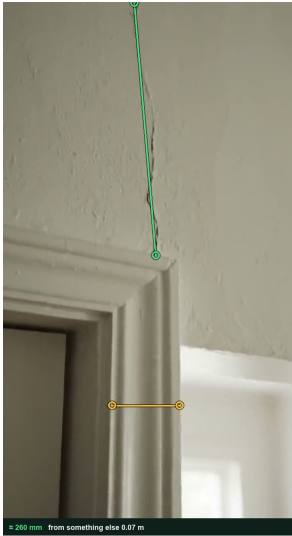
| Crack reference | IC2 |

| Where | Around a door or window opening |
| Orientation | Vertical |
| Widest width (mm) | 0.5 |
| Length (m) | 0.4 |
| Tapering | Even width |

| Other signs in this room | Hairline crack above the door head only. |
