# Kitchen Extract Cleaning Record (TR19 Grease)

| Project | The Spice House: kitchen extract clean to TR19 Grease (completed example) |
| Site address | High Street, Leicester |
| Clean date | 5 Oct 2026 |

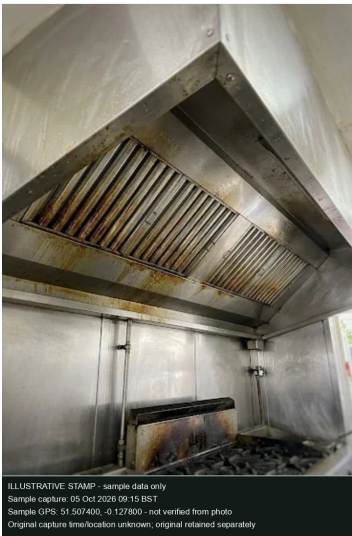
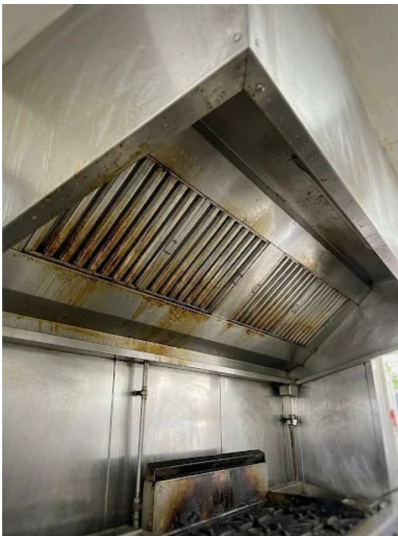
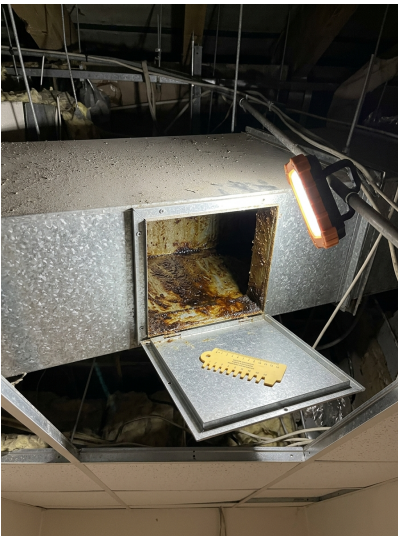
Before photos

| Mean before (microns) | 383 |
| Highest before (microns) | 520 |

A reading of 500 microns or more before the clean. TR19 Grease: grease deposits should not exceed a mean of 200 microns between cleans, and 500 microns or more needs immediate spot cleaning.

The mean before this clean is over 200 microns. TR19 Grease limits the mean to 200 microns between cleans, so a shorter cleaning interval may be needed.

| Areas not cleaned and why | None. Roof fan inlet spot cleaned first (520 microns). |

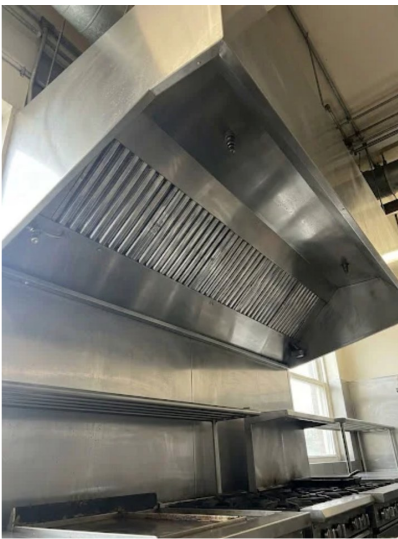
After photos

| Mean after (microns) | 40 |

One fire damper on the riser has no access panel; quoted to fit one. Last clean was about 3.1 months ago against the 3-month minimum for heavy use: next clean booked for early January.
