# Mold Inspection Checklist

| Site | 14 Palmetto Grove Lane, Tampa |

| Project | 14 Palmetto Grove Lane, Tampa: mold inspection (completed example) |
| Inspection date | 9 Oct 2026 |

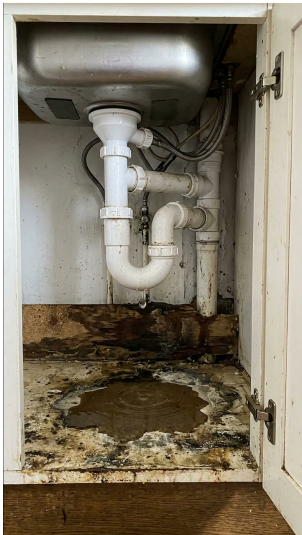
| Describe the source | Slip joint on the sink trap dripping into the base cabinet. Water standing on the cabinet floor. |
| Reading on the affected material | 38 |
| Reading on the same material in a dry area | 12 |
| Affected area above the dry reading | 26 |

| What you can see | Dark growth across the sink base panel and the back of the cabinet floor, swollen particleboard. Musty smell when the doors are opened. Nothing found on the wall behind the cabinet. |

| Action | Replace the leaking sink trap and check the drain for leaks. |

| Action | Remove the moldy sink base and cabinet floor, dry the cabinet, clean hard surfaces, fit a new base. |

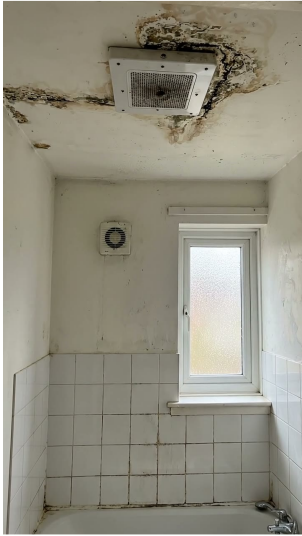
| Describe the source | Wall exhaust fan does not run on the switch. Tenant showers daily with the window closed. No roof leak found in the attic above. |
| Exhaust fan | Fitted, not working |

Growth and staining on the ceiling paint around the ceiling grille, spreading toward the wall. Ceiling readings only slightly above the dry ceiling in the hall, so condensation rather than a leak.

| Action | Replace the bathroom exhaust fan, ducted to the outside, then clean the ceiling, let it dry and repaint. |
