# Non-Conformance and Corrective Action Report

| Project | Unit 9, Brookfield Trading Estate, Doncaster |
| Report number | NCR-2026-047 |
| Customer | Larkspur Home Ltd |

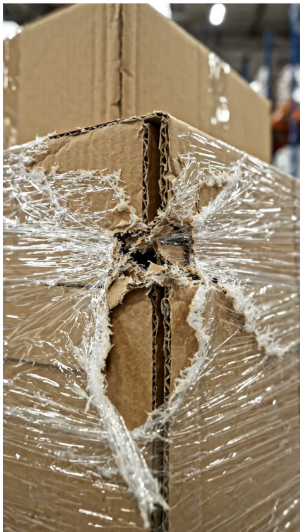
| What did happen? | Pallet 3 of 8 from Hollinbrook Lighting Ltd arrived with the wrap torn and 6 cartons on the top corner crushed. Cartons on that side overhung the pallet edge by about 50 mm. |
| Quantity or extent affected | 6 cartons of table lamps on 1 pallet, delivery note HL-58812 |

| Root cause | The supplier changed its carton size without updating its pallet stacking pattern, so cartons overhang the pallet edge and are crushed in transit. |

| Action | Return the 6 damaged cartons and raise a credit claim. |

| Action | Supplier to issue a new pallet pattern for the larger carton with no overhang, and send a photo of the first pallet built to it. |

| Action | Update the supplier delivery requirements so a supplier must send a new pallet pattern before changing a carton size, and add carton overhang to the goods-in check sheet. |
