# Pallet Racking Inspection

| Site | Larkfield Distribution, Unit 9 |

| Project | Larkfield Distribution, Unit 9: weekly racking inspection (completed example) |
| Date of inspection | 9 Oct 2026 |

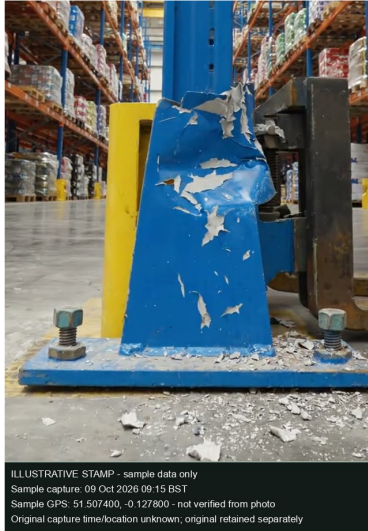
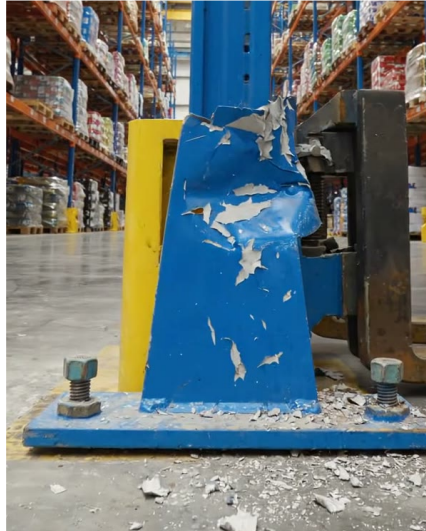
### Damage 1: Aisle 4, bay 12, front upright at floor level

| What is the damage? | Upright crushed and torn at the base, about 300 mm above the floor. Forklift strike. |
| Category | Red: offload now |

Racking contractor, by 13 October 2026

**Further actions 1: Replace aisle 4 bay 12 upright and inspect before reloading.**

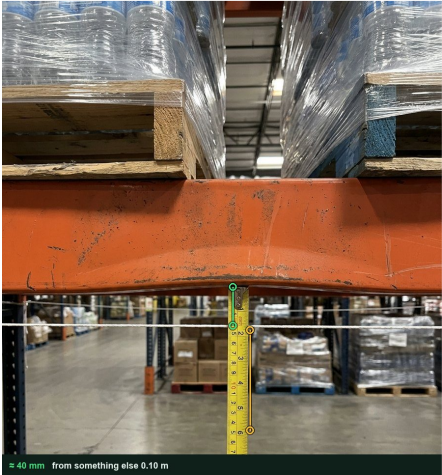
Sag at mid-span under load (mm): measuring photo

| What is the damage? | Beam visibly sagging under two pallets of bottled water. String line and tape at mid-span: the tape read about 40 mm, and the photo estimate is 40 mm. Load notice for this level is 1,000 kg per pair of beams. |
| Sag at mid-span under load (mm) | 40 |

Span / 200 for this beam (mm)13.5

Span divided by the sag68

More sag than span/200, the usual limit for a loaded pallet racking beam (EN 15635 and SEMA guidance). The beam may be overloaded or damaged: offload it and ask the racking supplier or an expert inspector before it is used again.

| Repair by (who and date) | Racking contractor to check the beam and the loads, by 13 October 2026 |

**Further actions 2: Check the beam at aisle 5 bay 7 level 2 and the weight of the bottled water pallets against the load notice before reloading.**

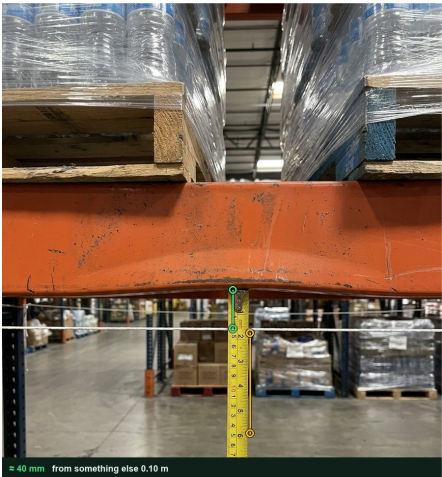
| Category | Red: offload now |
