# Park and Open Space Inspection

| Project | Riverside Park: monthly inspection (completed example) |
| Client | Riverbank Town Council |
| Inspection date | 6 Oct 2026 |

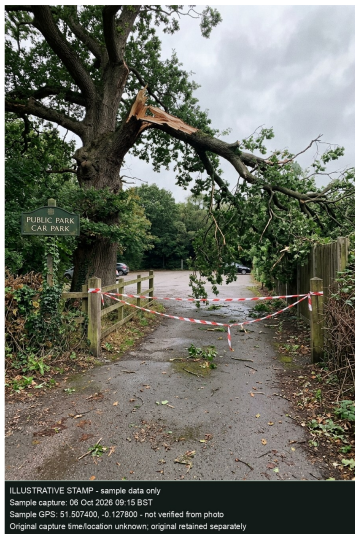
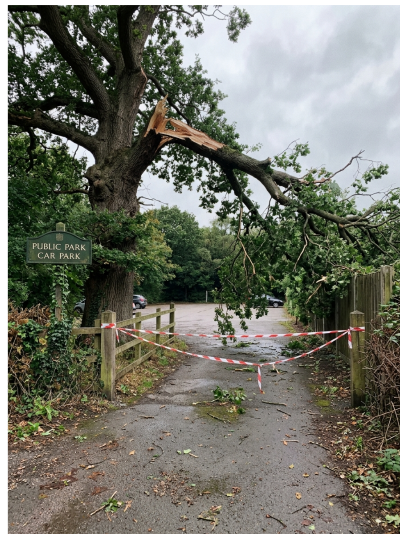
| Issue | Hanging branch over the car park entrance |
| Location | Car park entrance |
| Risk | High: make safe now |
| Made safe on site? | Yes |

| What needs doing? | Tree surgeon to remove the hanging branch; relay the two lifted slabs by bench 4 and assess the roots. |

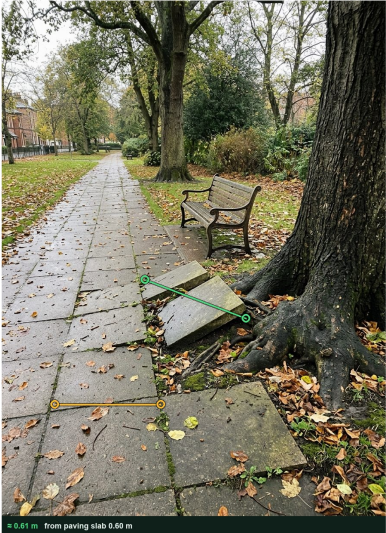
Length or size affected (m): measuring photo

| Issue | Two slabs lifted by tree roots, 25 mm upstand |
| Location | Riverside path by bench 4 |

| Risk | Medium |
| Length or size affected (m) | 0.61 |
