## SITE SURVEY REPORT

# Playground Visual Inspection

| Site | Hollins Park play area, Burnley |

| Project | Hollins Park play area, Burnley: weekly visual inspection (completed example) |

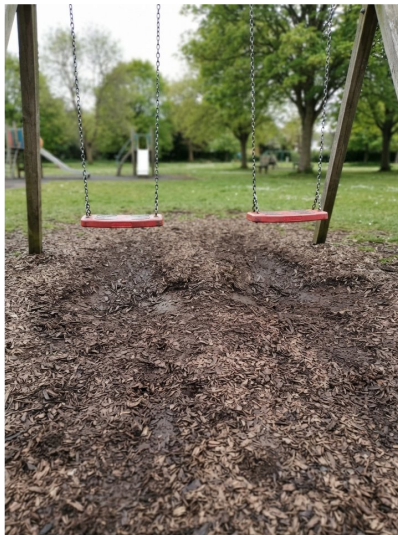
### Equipment item 1: PV-07-03 two-bay swing, centre of area

| Action, limitation or reason not applicable | Bark pit under the swing seats scuffed down, roughly 100 mm shallower than the rest of the pit. Topping up requested. |

| Visible damage, wear or missing parts | Bark worn away under both seats, hollows forming. Chains and shackles show normal wear only. |

| Restriction method and person notified | Raked bark back into the hollows. Grounds team supervisor C. Doyle told. |

**Further action 1: Top up bark under swings PV-07-03 to the level of the rest of the pit. Job PV-JOB-2290.**

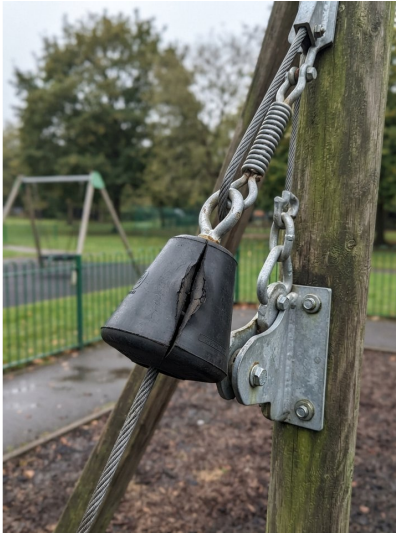
### Equipment item 2: PV-07-05 cableway, east side

| Visible damage, wear or missing parts | End stop buffer split along one side, still in place. Seat and cable look sound. |
| Action | Refer for specialist assessment |

| Restriction method and person notified | Reported to the supplier's inspector through job PV-JOB-2291. Equipment left open as the buffer still cushions the stop. |

**Further action 2: Supplier inspector to assess and replace the cableway end stop buffer. Job PV-JOB-2291.**
