## SITE SURVEY REPORT

# PPM Visit

| Project | Harbour House, Bristol: quarterly PPM visit (completed example) |
| Job or report reference | PPM-2026-0922 |

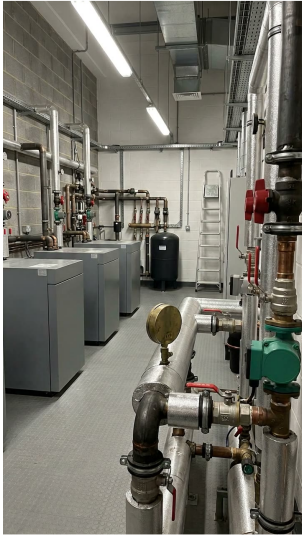
| Asset reference | BLR-01 |

| Boiler plant checks | Casings clean and undamaged, Flues secure, no staining, No leaks on flow and return, Valves labelled, Isolation valves exercised, Floor dry under the plant |

| Result | Pass |

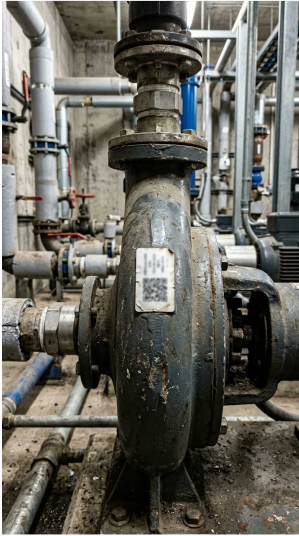
| Asset reference | PMP-02 |

| What did you find? | Surface rust or flaking paint, Isolation valve stiff |
| Which tasks were not completed, and why? | Suction isolation valve would not turn past a quarter. Did not force it. |
| Describe the defect | Suction isolation valve on pump 2 stiff, will not turn past a quarter. Surface rust and flaking paint on the pump casing. Pump running quietly, no leak at the seal. |

| Priority | Needs attention soon |

| Action needed | Replace the suction isolation valve and treat and repaint the casing. Needs a drain down of the secondary circuit. |
| Target date for the repair | 20 Oct 2026 |

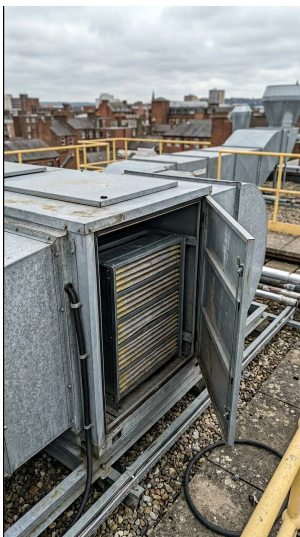
| Asset reference | AHU-01 |

| Filter condition | Dirty |
| Pressure drop across the filters (Pa) | 245 |
| Change point on the asset record (Pa) | 200 |
| Other checks | Belt tension and wear, Drain tray clear, Access door and seals, Casing free of holes |

| Result | Pass |

| Did you replace the filters on this visit? | Yes |
| Pressure drop with the new filters (Pa) | 95 |

Describe the work Replaced the panel and bag filters on AHU-01. Exercised the isolation valves on the boiler row and pumps. Swept the plant room floor.

Parts used, with quantities AHU-01 panel filters G4, 592 x 592 mm: 4. Bag filters F7, 592 x 592 mm: 4.

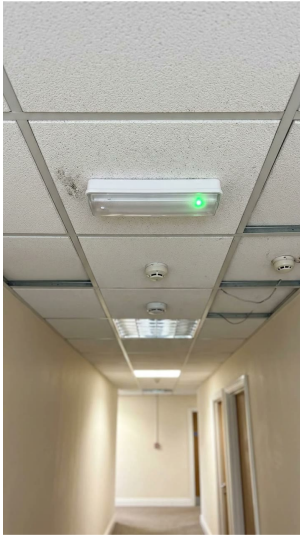
| Asset reference | EL-14 |

| Charge indicator | Lit |
| Fitting checks | Diffuser clean, Fitting secure, Not obstructed |

Did the fitting light on test? Yes

Result Pass
