# Pre-Demolition Survey

| Site | Brackley House, Swindon |

| Project | Brackley House, Swindon: pre-demolition survey (completed example) |
| Survey reference | RDC-EXAMPLE-114 |

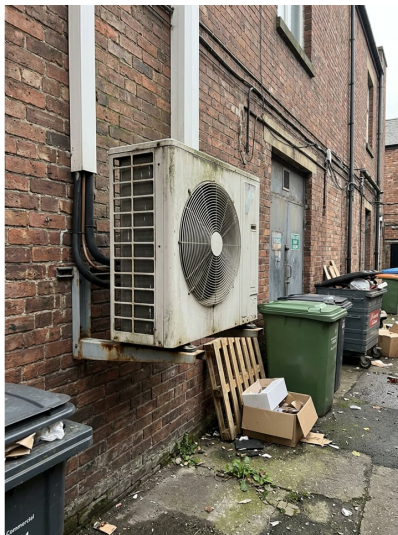
| <b>Refrigerants (air conditioning, chillers, cold rooms)</b> | Found |
| <b>Where, how much and what needs to happen, or why not checked</b> | Split air conditioning unit serving the former server room, condenser on the rear wall. Refrigerant to be recovered before removal. |

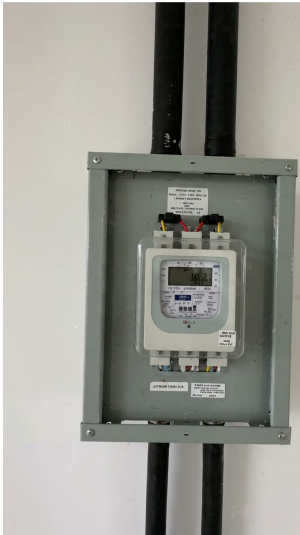
**Photos of the meter, isolation point or cap**

| Service | Electricity |
| Meter or isolation point | Intake cupboard in the entrance lobby |

| Status | Disconnection requested: waiting |
| Notes | Supply still live. Network operator to cut back to the boundary. |

| <b>Action</b> | Chase the electricity network operator for the cut-back to the boundary and get written confirmation. |

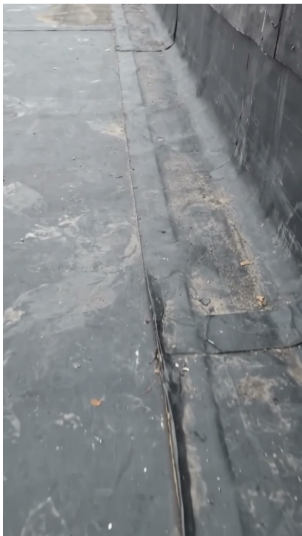
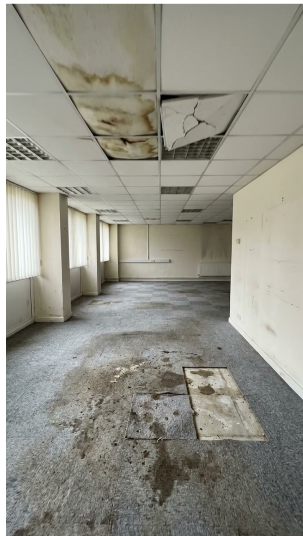
| Seen on the survey | Roof covering failed or leaking, Fire or water damage |
| Where, and what it looks like | Roof covering split along the upstand on the rear flat roof. Water has stained and brought down ceiling tiles in the open-plan office. Roof joists not seen. |

| Refer to the demolition engineer? | Yes |

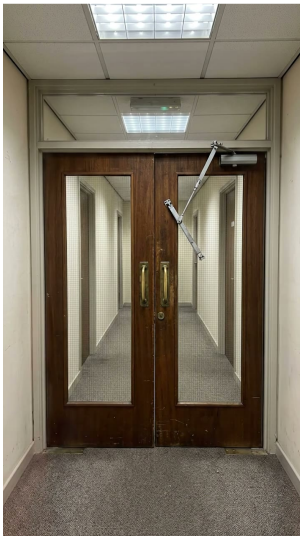
| Material or element | Timber glazed double doors |
| Condition | Good: reusable as it is |

| How to take it out and keep it, and who might take it | Take off with frames and closers, wrap and store dry. Local reclamation yard interested. |
