# Property Condition Assessment (PCA / FCA)

| Date | 14 Oct 2026 |
| Site | Glenwood Commons Office, Raleigh NC |

| <b>Project</b> | Glenwood Commons Office, Raleigh NC: property condition assessment (completed example) |

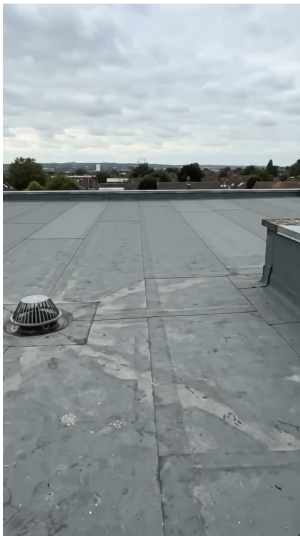
| Overall condition rating | Fair |
| Description | Single-ply membrane over rigid insulation and steel deck, about 19,600 sq ft, installed 2011, with parapets on all sides and four internal drains. |

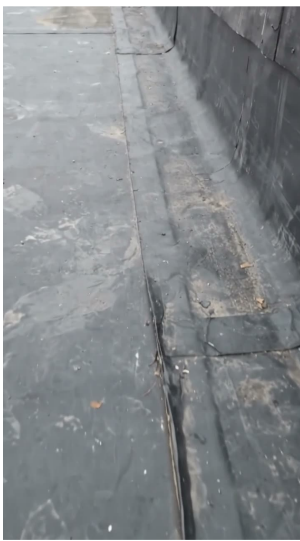
| Component | Membrane split at north parapet upstand |

| What they told you | Roof leak over suite 210 reported in September, not yet repaired. RTU-1 and RTU-2 had compressor repairs in 2025. Parking lot last sealcoated in 2019. |

| Condition rating | Poor |

| What was observed | Split along the base of the upstand about 2 ft long, water entering. Matches the leak over suite 210. |

| Recommended action | Repair |
| Priority | Immediate |
| Opinion of cost | 3800 |

| Action | Repair membrane split at north parapet upstand and water test. |

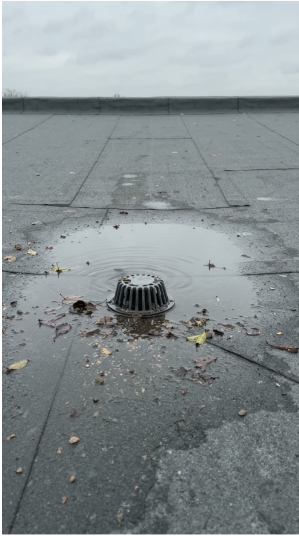
| Component | Roof drain RD-3 ponding |

| What they told you | Rooftop units are on quarterly service. Roof drain by the north parapet ponds after heavy rain. |

| Condition rating | Fair |
| What was observed | Ponding around the drain with leaf debris, strainer in place. |

| Recommended action | Repair |
| Priority | Short term |
| Opinion of cost | 1500 |

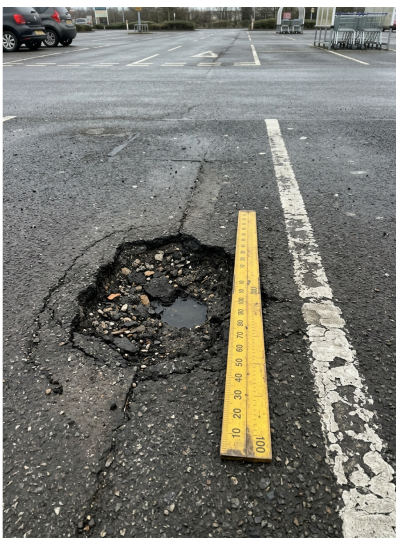
| Component | Pothole, row C near the south entrance |

| Condition rating | Poor |
| What was observed | Pothole in a drive aisle at a parking stripe, about 14 in across. |

| Recommended action | Repair |
| Priority | Immediate |
| Opinion of cost | 2400 |

| Action | Make safe and patch pothole in row C; cone off until repaired. |

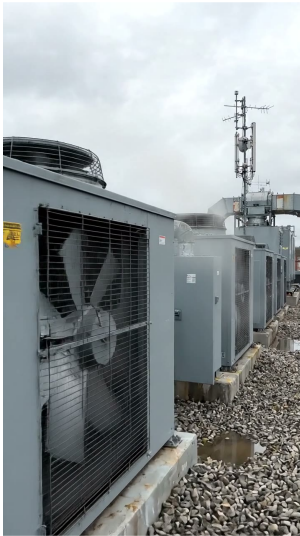
| Overall condition rating | Fair |
| Description | Four packaged rooftop units (RTU-1 to RTU-4) with gas heat, serving both floors through ducted VAV. |

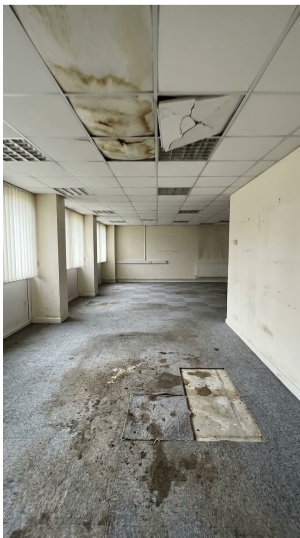
| Component | Ceiling tiles and carpet in suite 210 |

| Condition rating | Poor |
| What was observed | Vacant suite. Stained and broken ceiling tiles and stained carpet below the roof leak. |

| Recommended action | Replace |
| Priority | Immediate |
| Opinion of cost | 1200 |

| Action | Replace ceiling tiles and carpet in suite 210 after the roof repair. |
