# Pump Maintenance

| Site | Derwent Street Hotel, Derby |

| Project | Derwent Street Hotel, Derby: heating pump service (completed example) |

| Pump asset ID and location | P-LTHW-2, heating circuit pump (standby), basement plant room |

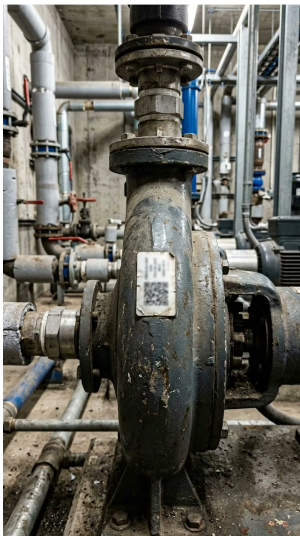
#### Condition and work evidence photos

| Action, limitation or reason not applicable | Slight weep at the mechanical seal, about one drop a minute when running. Casing has surface rust and dried deposits below the seal. |
| Action, limitation or reason not applicable | Suction strainer about half blocked with scale and debris. Cleaned and refitted with a new gasket. Discharge valve stiff, exercised and now free. |

| Actual value and unit | About 1 drop per minute |
| Acceptance range and source | No visible leakage, PM-PMP-03 |

| Response to exception | Seal replacement booked, job TM-26-1880. Drip tray placed under the pump and duty kept on P-LTHW-1 until repaired. |

| Work performed and parts used | Strainer cleaned, new strainer gasket fitted. Discharge valve exercised. Casing wire brushed below the seal so leakage can be seen. |

Action and evidence reference Replace mechanical seal on P-LTHW-2. Job TM-26-1880.
