## SITE SURVEY REPORT

# Retaining Wall Inspection

| Date | 6 Oct 2026 |
| Site | Moorside Road, Keighley |

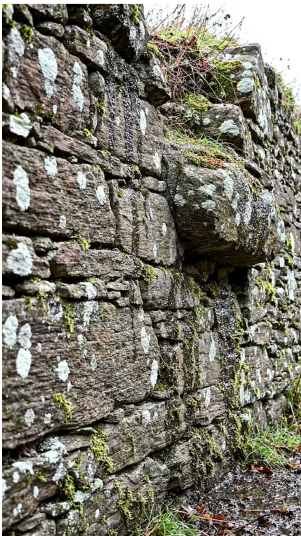
**Defects 1: Bulging**

| What is wrong? | Bulge over about 3 m, 6 to 9 m from the west end |

| Defect | Bulging |
| Location (distance along the wall, height) | 6 to 9 m from the west end, mid height |
| Size, in words | Face bowed outwards over about 3 m |
| Length along the wall (m) | 3.10 |
| How far out of line (mm) | 40 |
| Offset at the last inspection (mm) | 25 |
| Change since the last inspection (mm) | 15 |
| Risk | Refer to an engineer |

**Further actions 1: Structural engineer to inspect the bulge and advise on repair.**

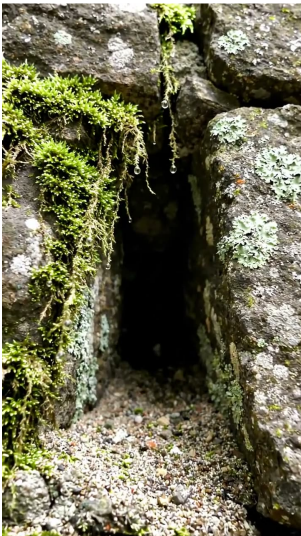
Defects 2: Missing or displaced stones

| What is wrong? | One face stone missing at the crack |

| Defect | Missing or displaced stones |
| Location (distance along the wall, height) | 7.5 m from the west end, 1.2 m up |
| Size, in words | One face stone missing, void behind |
| Length along the wall (m) | 0.30 |
| Risk | Danger: make safe now |
| Made safe or cordoned off? | Yes |

**Further actions 2: Keep the barrier on the footway edge below the missing stone until the engineer has visited.**

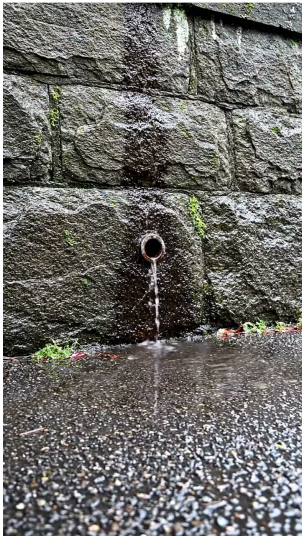
**Defects 3: Water seepage**

| What is wrong? | Two drain holes blocked with soil |

| Defect | Water seepage |
| Location (distance along the wall, height) | Drain hole below the bulge |
| Size, in words | Running after rain, wet patch below |
| Length along the wall (m) | 1.00 |
| Risk | Monitor |

**Further actions 3: Clear the two blocked drain holes.**
