## SITE SURVEY REPORT

# Retrofit Assessment Record

| Project | 3 Holly Terrace: retrofit assessment (completed example) |
| Site address | 3 Holly Terrace, Sheffield |

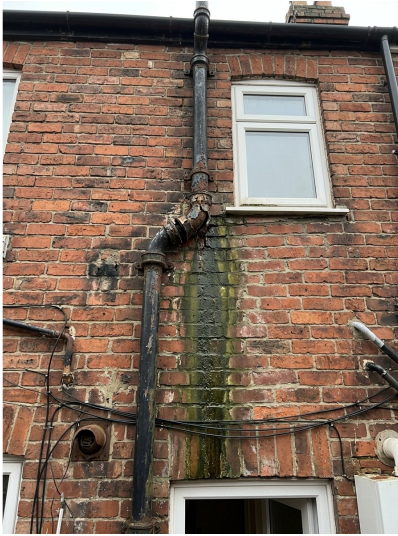
#### Defects found 1: Gutters or downpipes

| Defect | Gutters or downpipes |

| Where | Rear downpipe, joint at first floor level |

| When to fix | Before any measures |

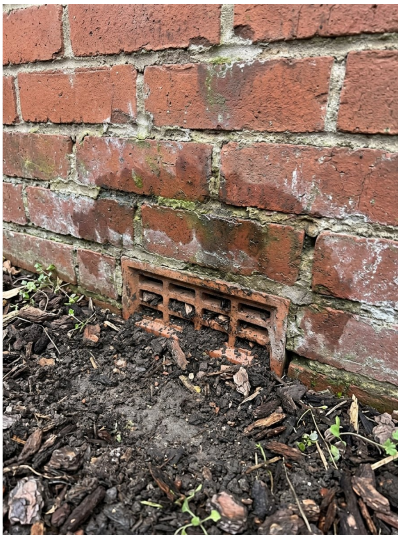
**Defects found 2: Blocked air bricks**

| Defect | Blocked air bricks |
| Where | Front, both air bricks under the bay |

| When to fix | Before any measures |
