# Risk Assessment

| Prepared for | Holloway Street rear extension, Derby (fictional) |

| Assessment reference | RA-HS-004 |
| Work covered by this assessment | Fixing first fix services at high level from a mobile tower, and connecting the new drainage to the east side manhole. |

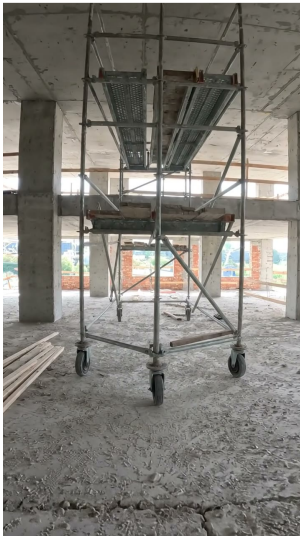
| What is the hazard? | Fixing containment and brackets to the soffit from a mobile tower. |
| Who might be harmed, and how? | Tower crew could fall from the platform or the tower could tip while being moved. |

2. Unlikely

4. Major injury

Medium

Check the instruction manual on stabilisers for this height and fit them if required before use.

24 September, 08:05: stabilisers fitted as the manual requires. Checked by B. Nwosu.

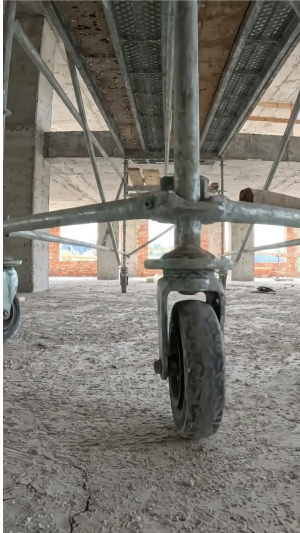
PASMA trained crew. Tower built on the level slab with castors locked.  
Nobody on the platform while it is moved.

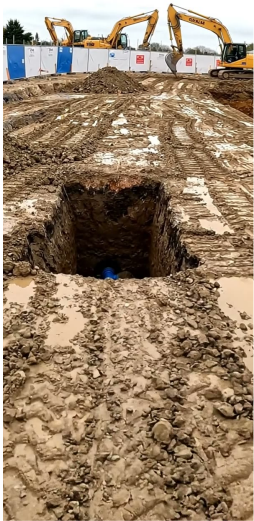
| What is the hazard? | Open trench at the manhole connection, about 1.2 metres deep, with no barrier. |
| Who might be harmed, and how? | Anyone walking past, or plant reversing, could fall into the trench. |

| What protects the edge? | Nothing in place |

Unprotected edge. Suitable and sufficient steps must be taken to prevent any person, work equipment or material from falling into an excavation. Construction (Design and Management) Regulations 2015, regulation 22.

| Rating | High |

| Further action needed | Fit barriers around the trench, with a 1 metre stand-off, before any work in the area. |
| Done on (date) and checked by | 24 September, 09:30: barriers up with a 1 metre stand-off. Checked by B. Nwosu before work resumed. |

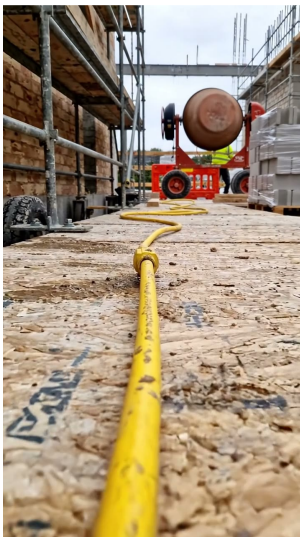
| What is the hazard? | 110 V extension lead laid across the walkway to the mixer. |
| Who might be harmed, and how? | Anyone using the walkway could trip on the lead. |

| What is underfoot? | Trailing lead or cable, Wet or muddy surface |

**Rating** Medium

**Further action needed** Reroute the lead overhead on hooks along the scaffold and brief the crew.

**Done on (date) and checked by** 24 September, 08:30: lead rerouted on hooks. Checked by B. Nwosu.
