# Roof Inspection

| Site | Moorfield Community Centre, Leeds |

| Project | Moorfield Community Centre, Leeds: roof inspection |
| Date of inspection | 25 Sep 2026 |

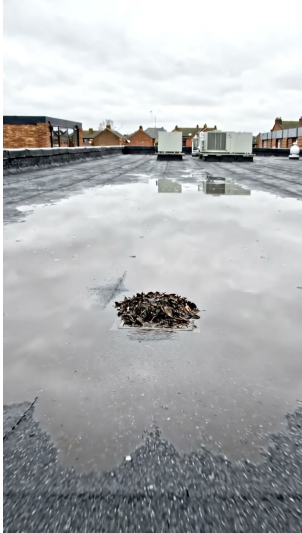
### Roof areas 1: Main hall roof

| Condition | Poor |

| Defects seen | Ponding water, Blisters, splits or open laps, Previous patch repairs |
| Notes | Large pond in the middle, about 4 x 3 m, 30 mm deep at the centre. Two laps open next to old patches. |

| What is wrong? | Open laps next to old patches, under the ponding. Likely source of the leak into the hall. |

| Recommended repair | Patch repair the open laps now to make the roof watertight. Plan a full re-cover with improved falls within two years. |

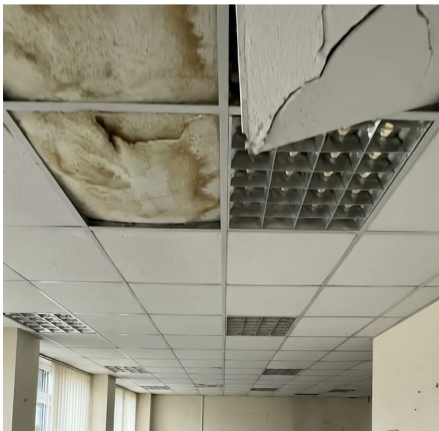
| Why not? | No access to the void above the suspended ceiling in the hall |
| Stains on ceilings in the rooms below? | Yes |

| What is wrong? | Stained ceiling tiles, one broken |

| Recommended repair | Replace tiles once the roof is watertight |

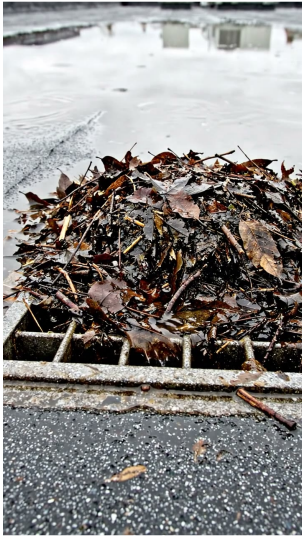
### Defects 1: Rainwater outlet, north west corner of the main roof

| What is wrong? | Outlet blocked with leaves, water backing up across the roof |
| Priority | Urgent: make safe or watertight now |

| Recommended repair | Clear the outlet and rod the downpipe. Fit a leaf guard. |
