# Safety Observation Report

| Date | 13 Oct 2026 |
| Site | Larkhill Fields Phase 2, Banbury |

| Project | Larkhill Fields Phase 2, Banbury: safety observation (completed example) |

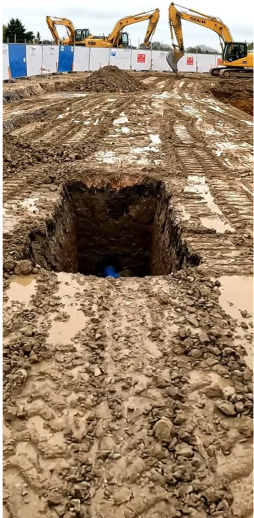
| What did you see? | Service connection pit about 1.2 m deep left open overnight with no barrier or edge protection on any side, beside the haul route used by the dumper and by bricklayers walking to plots 30 to 34. Water main exposed in the bottom. |

| Why do you think it happened? | Equipment missing or damaged, Rushing or a shortcut |
| Anything else about why | Barriers for the service pits were not on the groundworks order for this phase. |

| How was it made safe? | Four interlocking pedestrian barriers placed round the pit from the compound stock, and the dumper driver told to use the other side of the road until the groundworks gang arrived. |

| Action | Bring enough barriers to site to guard every open service pit, and check each pit at the end of the shift. |

| Action | Add open pits and barriers to the groundworks end-of-day check and brief it at Thursday's toolbox talk. |
| Evidence it was put right | Barriers on all four sides of the open pits at plots 33 and 34 on 13 October, checked at 11:40; plot 31 pit backfilled after the connection that afternoon. End-of-day pit check briefed at the toolbox talk on 15 October. |
