## SITE SURVEY REPORT

# Scaffold Tag Inspection Record

| Date | 13 Oct 2026 |
| Site | Orchard Gate, Blocks C and D, Wantage |

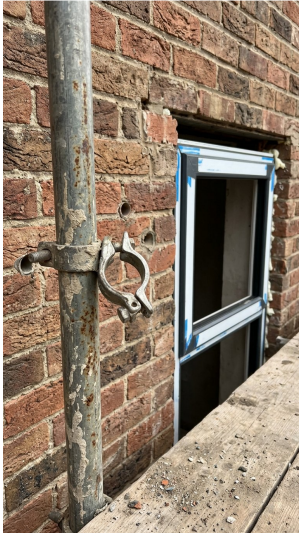
Photos: the tag in its holder and any defect

| What needs doing, or why not checked | Tie removed at lift 2 beside the plot 23 first floor window opening, no replacement tie fitted. Window fitters say they took it out on Friday to fit the frame. |
| Status written on the tag | Not safe to use |
| How it was taken out of use, and who was told | Green insert swapped for red at the ladder bay, ladder pulled up and access barriered at 07:55. Site manager R. Haines and the window fitting foreman told at 08:00. |

| <b>Matters found that could give rise to a risk</b> | SC-07: tie removed at lift 2 beside the plot 23 window, no replacement.<br>SC-09: toe board missing at lift 1, bay 3. |

#### **Actions 1: Ridgeline to fit an equivalent tie beside the plot 23 window at lift 2, then SC-07 to be inspected and retagged.**

| <b>Action</b> | Ridgeline to fit an equivalent tie beside the plot 23 window at lift 2, then SC-07 to be inspected and retagged. |

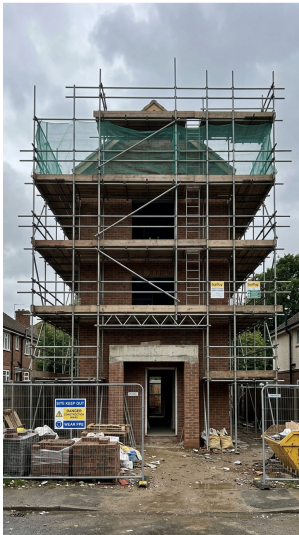
## Photo of the whole scaffold

| What happened or what was changed | Gusts of wind over the weekend. Netting on the top lift checked for tears and loose ties. |

| What needs doing, or why not checked | One toe board knocked off at lift 1, bay 3. Refitted by Ridgeline at 08:30 and checked before the tag was signed. |

Action Toe board refitted at SC-09 lift 1, bay 3.
