# Schedule of Condition

| Project | 27 Holmfield Terrace, Headingley, Leeds: schedule of condition |
| Report reference | SOC-2026-071 |
| Why is the schedule being made? | Party wall award |

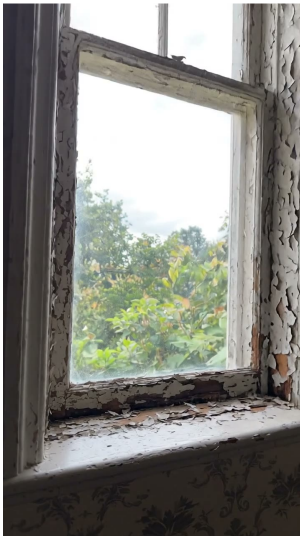
## Photos of the windows

| Windows | Poor |
| Windows: notes | Original timber sash, paint failing on the inside, soft timber at the bottom rail |

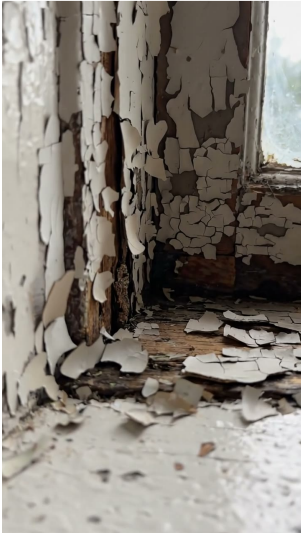
Close-up photos of the damage

| Describe the damage: what, where, and its size in mm | Flaking paint and bare timber on the inner lining and bottom rail of the sash, about 450 x 120 mm. Ceiling crack at the party wall junction, hairline, under 1 mm wide. |
| Length of the longest crack or damage (mm) | 450 |

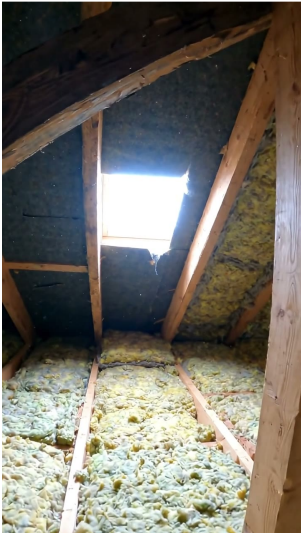
Photos of the ceiling

| Ceiling | Fair |
| Ceiling: notes | Underside of the roof. Felt torn beside the chimney breast, daylight visible. |

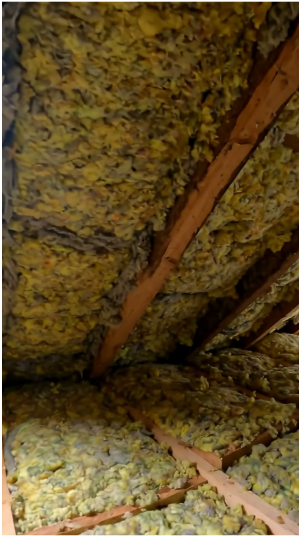
## Photos of the floor

About 100 mm of mineral wool between the joists, no boarding

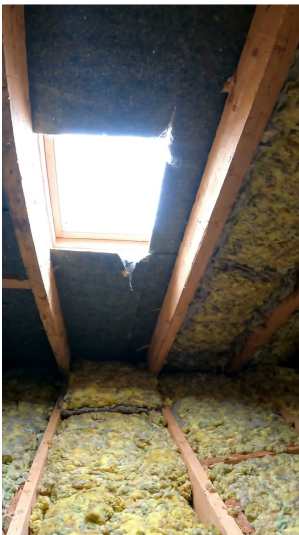
## Close-up photos of the damage

Torn felt beside the chimney, opening about 300 x 200 mm. Old water staining on the rafter below, dry on the day.

300

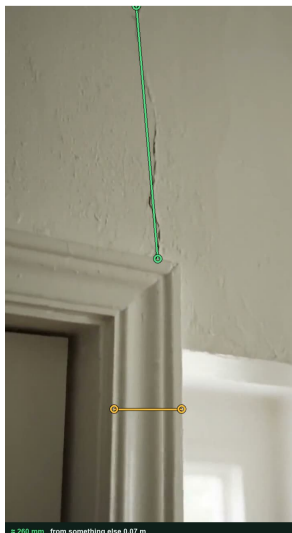
**Length of the longest crack or damage (mm): measuring photo**

| Describe the damage: what, where, and its size in mm | Crack in the plaster rising from the right hand corner of the door architrave to the ceiling line, about 260 mm long, up to 1 mm wide at the architrave and hairline above. Measured against the architrave, 70 mm wide by tape. |
| Length of the longest crack or damage (mm) | 260 |

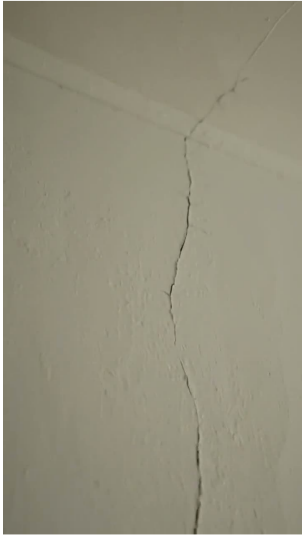
## Close-up photos of the damage

| Walls: notes | Party wall plaster cracked above the rear bedroom door, plaster sounds hollow beside it |

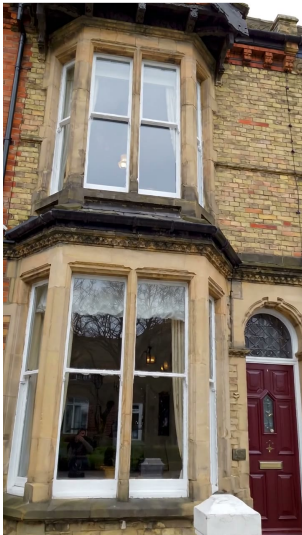
#### Photos of the area

| Notes | Red brick with stone bay and dressings. Pointing fair. No cracks seen at the party wall line. Shared chimney stack on the party wall seen from the street, pots in place. |

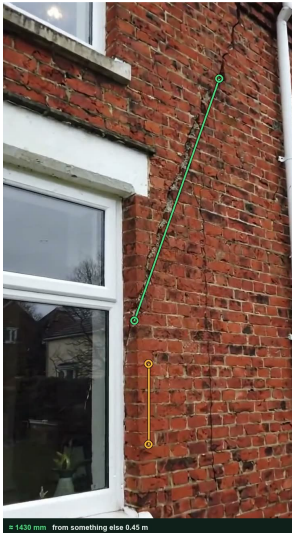
**Length of the longest crack or damage (mm): measuring photo**

| Describe the damage: what, where, and its size in mm | Diagonal crack through the mortar and some bricks, rising from the right hand reveal of the kitchen window head towards the first floor window. About 1430 mm long, up to 5 mm wide at the lower end, hairline at the top. A second hairline crack runs vertically to its right. Measured against six brick courses, 450 mm by tape. |
| Length of the longest crack or damage (mm) | 1430 |

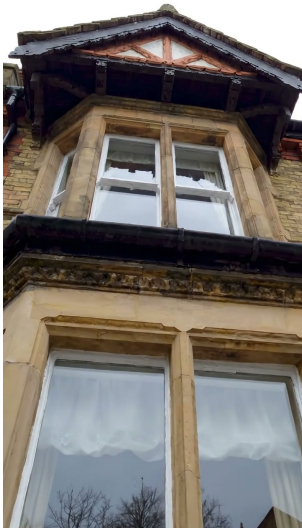
**Close-up photos of the damage**

| Describe the damage: what, where, and its size in mm | Gutter above the bay dips about 25 mm at the middle, joint dripping onto the bay roof. Dip runs over about 900 mm. |
| Length of the longest crack or damage (mm) | 900 |
