# Site Inspection

| Report reference | HH-COW-09 |
| Project and area | Harbour House, 40 Wellington Street, Leeds, level 2 fit-out |
| Date of the visit | 24 Sep 2026 |

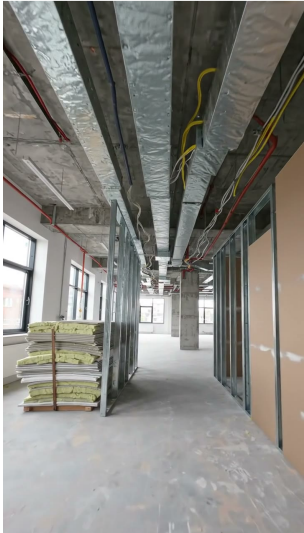
##### Areas inspected 1: Zone A, open plan office, west side

| Which looks most like the stage the work has reached? | Framing up, ceilings open |

| Is there a finding in this area? | No |

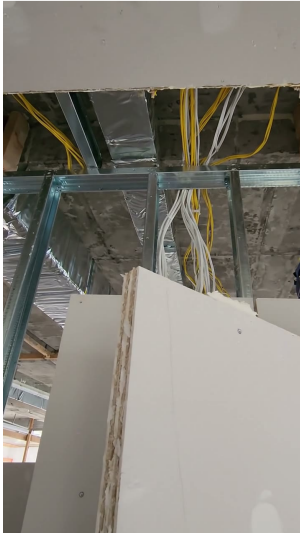
Areas inspected 2: Meeting room 4, east side

| Why is it behind, and what will bring it back? | Head detail held up waiting for the fire stopping subcontractor. Drylining gang to finish once the head is sealed. |
| Is the head built and sealed to the slab as the drawings show? | No |
| What did you find? | Partition head not sealed to the slab above meeting room 4. Open along about 1.2 m where the data cables pass through. |
| Type of finding | Incomplete work |

| When does it need to be put right? | Before it is covered up |
| Who needs to act? | Ashcombe Interiors, drylining supervisor |
| Due date | 1 Oct 2026 |

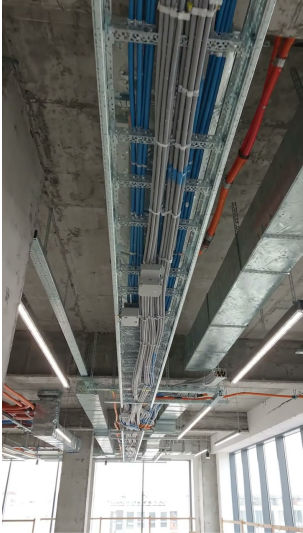
## Areas inspected 3: Ceiling void, zones B and C

| Which looks most like the stage the work has reached? | Containment in, cables pulled |
| Why is it behind, and what will bring it back? | Containment complete. Cabling pulled to zone B, zone C still to do. Two more electricians start on 28 September. |
| Is there a finding in this area? | No |
