# Site Safety Inspection

| Project | Millbrook Fields phase 2, Lincoln: site safety inspection (completed example) |
| Report reference | SSI-MF2-031 |
| Date of the inspection | 29 Sep 2026 |

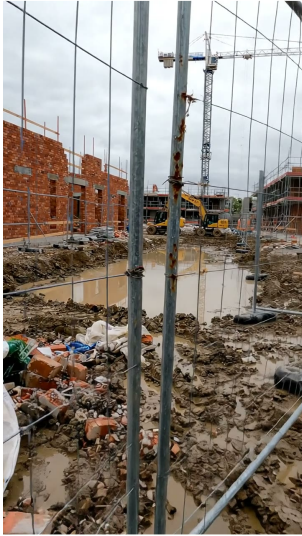
| Condition of the fence or hoarding | Loose, damaged or missing in places |
| Where is it loose, damaged or missing? | Heras panel by gate 2, coupler loose and held with tie wire only |

| Was it made secure during the walk? | Yes |

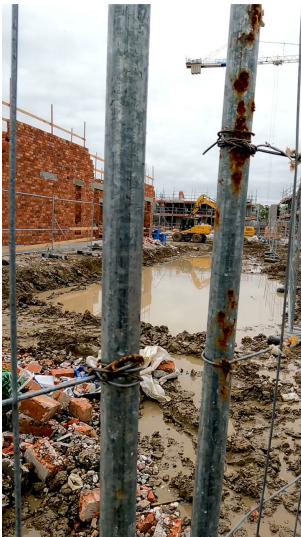
| Hazard | Loose or missing fencing |
| Exact location | Gate 2, Hykeham Road side |
| What you can see, and who could be harmed | Panel coupler loose after the rain, held by tie wire. Panel could be pushed open from the footpath. |

| Likelihood (1 unlikely, 5 very likely) | 3 |
| Severity (1 minor, 5 fatal) | 3 |
| Risk score | 9 |

| What was done, and at what time? | New coupler and brace fitted by the labourer at 08:40 |

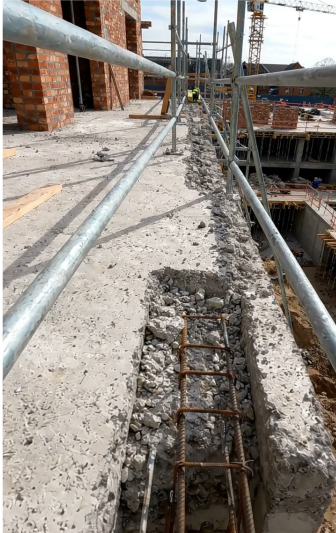
| Hazard | Open hole or excavation |
| Exact location | Plot 22, first floor slab |

Open column pocket with exposed reinforcement next to the walkway. A worker could step or fall into it.

12

Medium risk. Give the action an owner and a due date.

Area barriered and work on the slab stopped at 08:55

Fit a fixed, marked cover over the pocket until it is concreted.

2026-09-29. Cover fixed and marked at 11:20, checked by G. Holt. Slab work restarted 11:30.

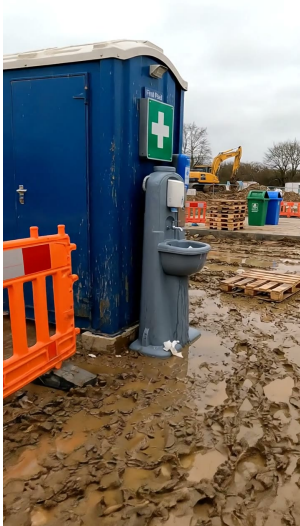
Slip or trip

Hand wash station by the welfare cabin

Standing water and mud around the hand wash and cabin step. Paper towels on the ground.

6

Low risk. Record the action and check it at the next inspection.

Lay a stone path and duckboards to the welfare cabin. Add a bin by the hand wash.
