# Site Visit Report

| Project | Riverside Court, 12 Quay Road, Hull |
| Site | Riverside Court, basement plant room |
| Date of visit | 23 Sep 2026 |

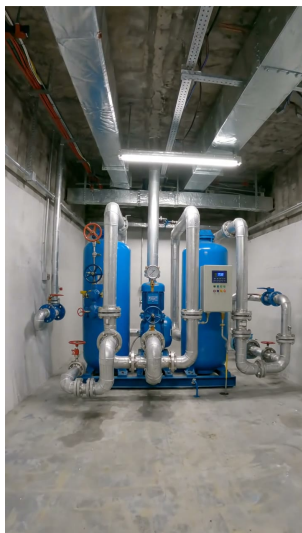
### Findings 1: Plant room, cold water booster set

| Observation | Booster set running, both pumps cycling normally. No leaks on the pipework or valves. Pressure held steady while a tap was run on floor 6. |

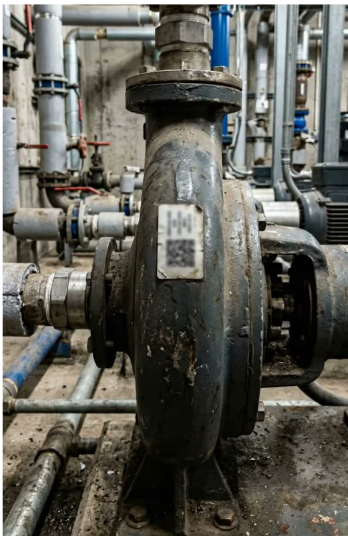
**Findings 2: Plant room, hot water return pump**

Return pump noisy with a bearing rumble and flow on the return is weak. Return at the calorifier 47 °C, below the 50 °C that HSE legionella guidance (HSG274 Part 2) expects. Isolation valve on the outlet side is stiff. Likely cause of the slow hot water on the top floors.

Replace the hot water return pump and free off the isolation valve. Low return temperature reported to Northgate's legionella responsible person on the day.

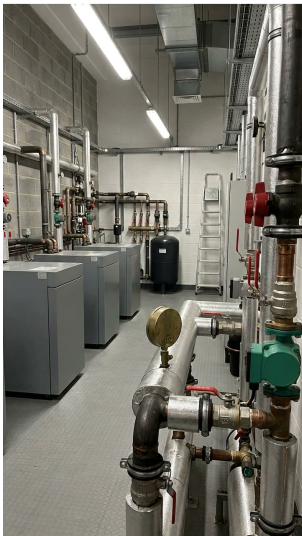
**Findings 3: Boiler room**

Boilers 1 to 4 running, no fault codes. Flow temperature at the calorifier 62 °C. Pipework labelled, no leaks seen.

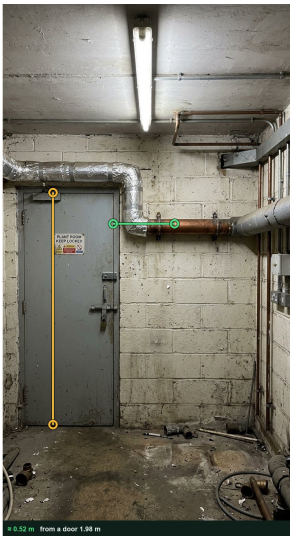
Measurement, if one is needed (m): measuring photo

| Measurement, if one is needed (m) | 0.52 |

What was measured? Length of uninsulated pipe, measured from a photo against the plant room door

| Action | Refit pipe insulation to the exposed run, about 0.5 m of 42 mm pipe |

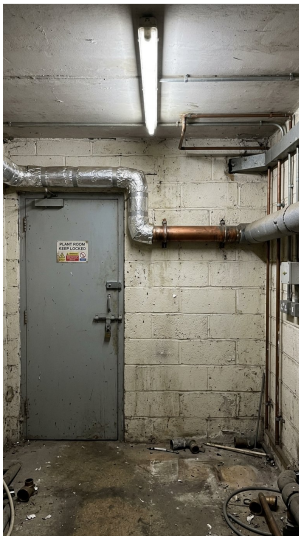
Findings 4: Plant room, hot water flow to the risers

| Observation | Pipe insulation missing on the hot water flow along the wall by the plant room door, probably not refitted after the valve change in August. Heat loss into the plant room and a hot surface at head height. |
