# Smoke Vent and AOV Inspection

| Prepared for | Kingsley Court RMC |
| Site | Kingsley Court |

| Project | Kingsley Court: quarterly AOV test (completed example) |

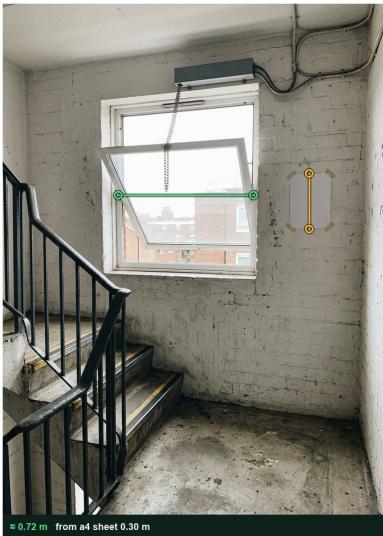
Clear frame opening width (m): measuring photo

Clear frame opening width (m)0.72

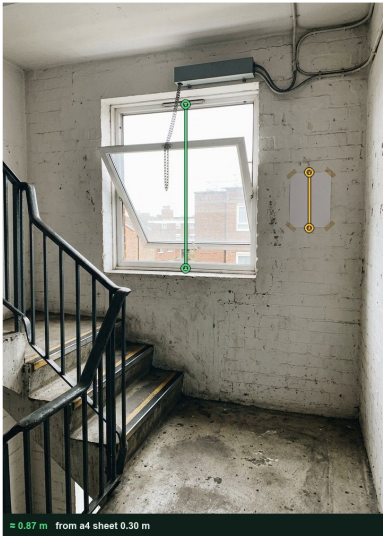
Clear frame opening height (m): measuring photo

Clear frame opening height (m)0.87

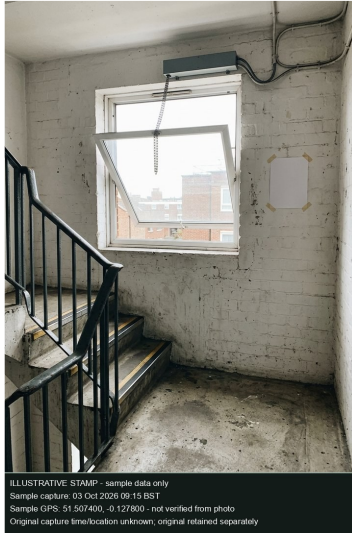
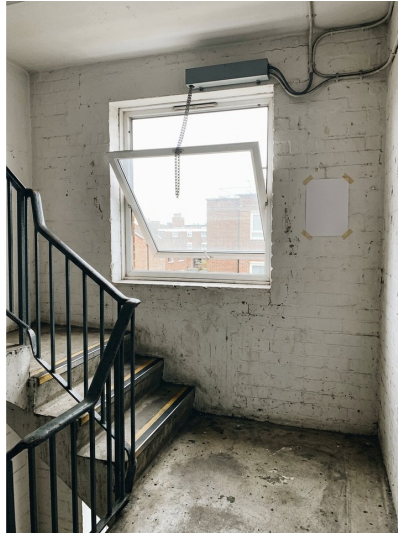
| Position (stair head, corridor, lobby) | Level 4 landing |
| Type | Window AOV |
| Time to open (seconds) | 32 |
| Opening time check | Within the maximum |

Opening against the designAt least the design free area
