# Snagging Inspection

| Project | Plot 14, Meadow Rise, Garforth: snagging inspection |
| Report reference | SN-P14-01 |
| Plot or property | Plot 14, Meadow Rise, Garforth, Leeds LS25 2DW |

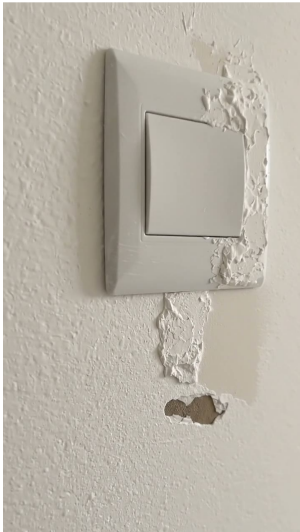
#### Snags 1: Living room

| Exactly where? | Light switch by the door to the hall |
| What is wrong with the wall or ceiling? | Plaster chipped or damaged, Paint patchy or uneven |
| Describe the snag | Plaster chipped around the switch plate and below it, paint patchy where it was touched in |

| Trade to put it right | Plasterer |
| Priority | Before handover |

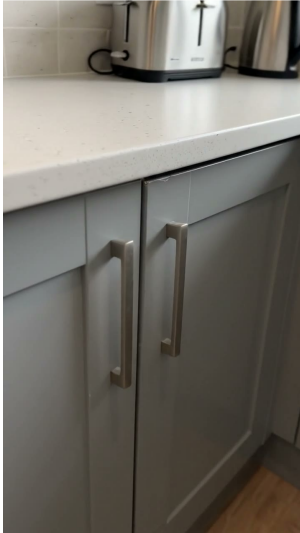
#### Snags 2: Kitchen

| Exactly where? | Corner base unit, left of the cooker |

| What is wrong with the unit? | Door out of line, Door does not close flush |
| Describe the snag | Pair of doors out of line by about 3 mm, left door stands proud when closed |

| Trade to put it right | Kitchen fitter |
| Status | Fixed, waiting for a check |

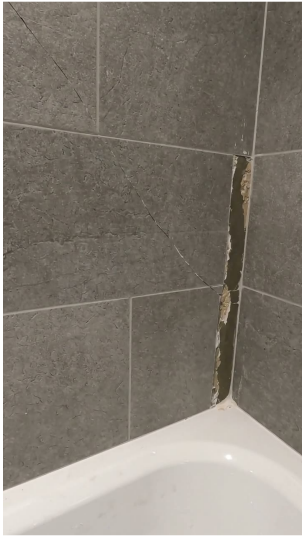
## Snags 3: Bathroom

| Exactly where? | Internal corner of the tiling above the bath |
| What is wrong with the tiling? | Grout missing |

An open joint or cracked tile in a wet area lets water get behind the tiles. Put it right before the bath or shower is used.

**Describe the snag** Vertical corner joint open, grout missing for about 400 mm above the bath

| <b>Trade to put it right</b> | Tiler |
| <b>Priority</b> | Before handover |
