# Solar Installation Site Survey

| Site | 22 Holly Road, Harrogate |

| Project | 22 Holly Road, Harrogate: solar PV site survey (completed example) |

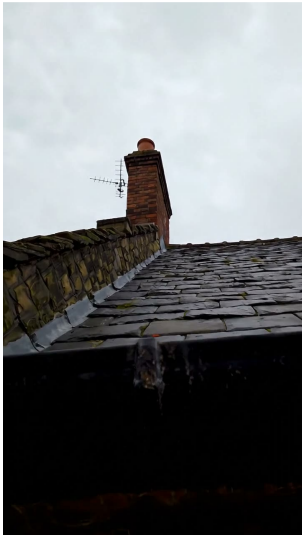
| Area ID and orientation | Area A, rear main slope, facing south-west |

| Observed dimensions, pitch and measurement method | About 7.5 m wide by 4.5 m on slope, pitch about 40 degrees. Estimated by counting slate courses and from the loft. |
| Visible condition and fragility concerns | Slates generally sound from below, some moss. Chimney stack and aerial on the party wall side. Fragility of slates under foot is a concern; no walking on the roof. |

Chimney stack shades the left side of the slope in the late afternoon. Observed at 15:30.

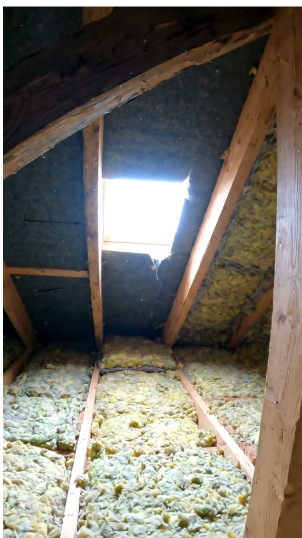
Area A from inside, roof void

Rafters at about 400 mm centres, measured with tape in the loft

Torn sarking felt around the roof light, daylight visible. Rafters dry, no obvious rot seen from the loft.

No roof access without scaffold. Chimney shading on the left side. Felt repair needed around the roof light.

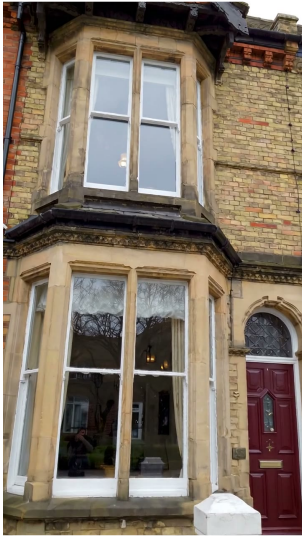
Area B, front bay roof, facing north-east

Small, shaded and on the street elevation. Not proposed.
