## SITE SURVEY REPORT

# Solar Panel Maintenance

| Site | Hollins Farm, Kendal |

| Project | Hollins Farm, Kendal: barn roof solar PV maintenance (completed example) |

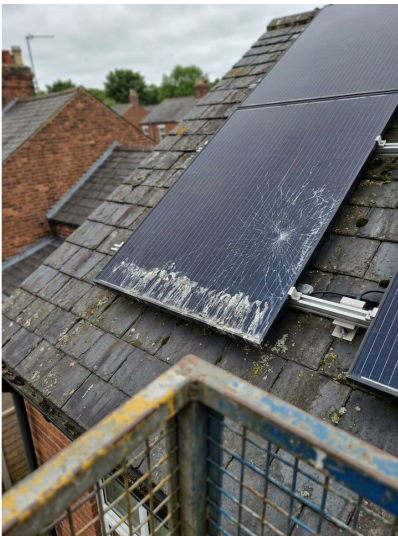
Condition and work evidence photos

| Action, limitation or reason not applicable | One module in string 3, row 2 position 14, has cracked front glass. Heavy bird soiling on the bottom two rows, cleaned with water and a soft brush. |
| Action, limitation or reason not applicable | One cable on string 3 hanging loose under the module edge, not clipped. Labels at inverters and isolators present and legible. |
| Action, limitation or reason not applicable | INV-2 insulation warning in the log on 2026-09-02. Likely related to the cracked module on string 3. For specialist testing. |

| Work performed and parts used | Rows 1 and 2 cleaned. Loose string 3 cable clipped back with UV-stable clips. String 3 DC isolator opened and tagged. |

| Action and evidence reference | Replace the cracked module on string 3 and carry out DC insulation resistance test on the string. Report LSS-TR-26-118. |
