## SITE SURVEY REPORT

# Stationary Battery Maintenance

| Project | Ouseburn Data Suite, Newcastle upon Tyne: UPS battery maintenance (completed example) |

| Stationary battery bank asset ID and location | BAT-UPS1, UPS battery string in cabinet BC-1, ground floor UPS room |

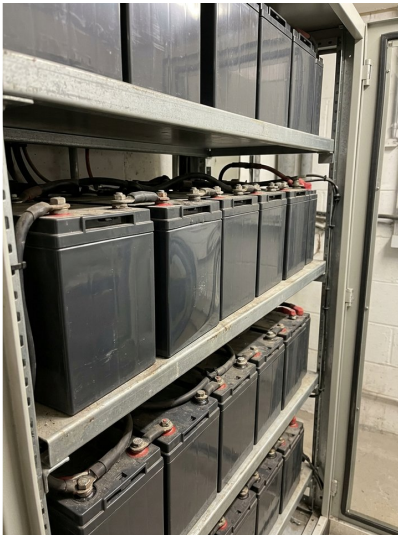
#### Condition and work evidence photos

| Action, limitation or reason not applicable | Block 27 case slightly swollen on one side. No leakage or smell. Block temperature same as its neighbours. |

| Response to exception | Low and swollen. Replacement block ordered, PO TPS-PO-5521. Block 27 to be rechecked weekly until replaced. |

**Further action 1: Replace block 27 with a matching block and recheck string and block voltages. PO TPS-PO-5521.**
