# Store Fixture Survey

| Site | Greenleaf Health, store 214 Bath |

| Project | Greenleaf Health, store 214 Bath: fixture survey for refit |

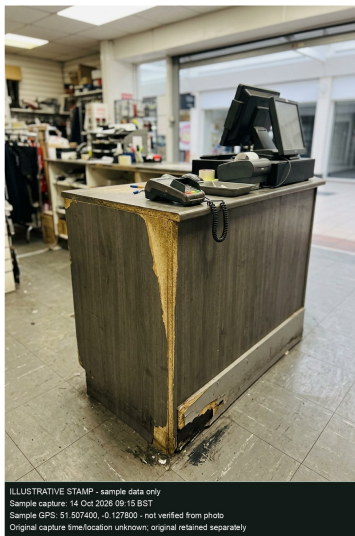
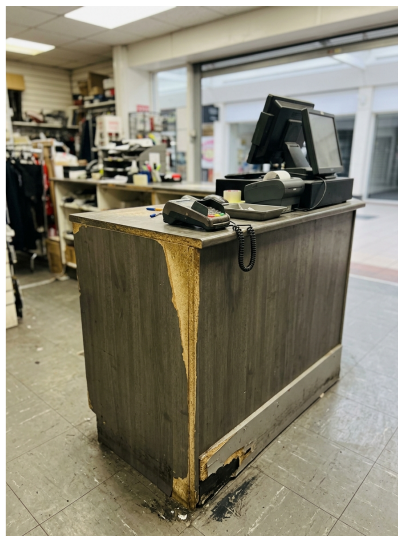
| Fixture ID or tag | C-01 |

| Condition | 2: poor |
| Damage | Peeling laminate, Dented |

Corners worn through to the board and the kick panel chipped. Power and data come up through the floor at the left end.

| Recommended action | Replace with new design |

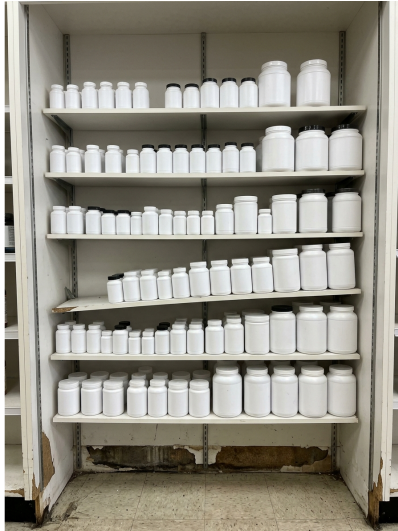
| Fixture ID or tag | W-03 |

| Condition | 2: poor |

**Damage** Peeling laminate, Broken brackets

**Notes** Laminate peeling along the plinth on all three bays. Second shelf from the bottom on bay 2 sits on a bent bracket and tilts; emptied during the visit.

**Recommended action** Replace with new design

**Further actions 1: Keep the tilted shelf on wall bay W-03/2 empty until the bracket is replaced.**

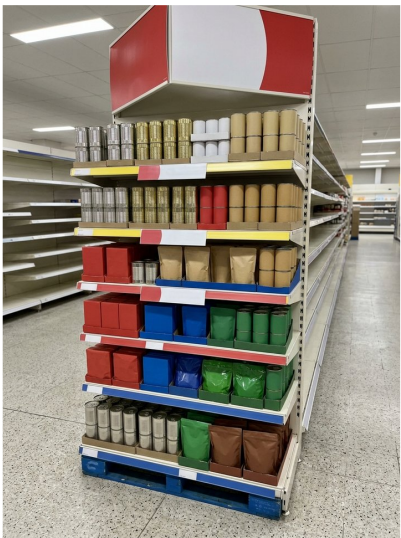
| <b>Fixture ID or tag</b> | G-01 |

| Condition | 3: worn |
| Damage | Scratched |

| Recommended action | Refurbish |

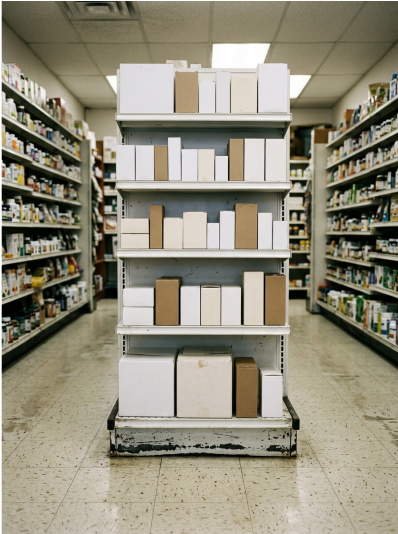
| Fixture ID or tag | E-02 |

| Condition | 3: worn |
| Damage | Scratched, Dented |

| Notes | Base plinth chipped and scuffed by trolleys on both end caps. Uprights straight. Respray the plinths and fit kick plates. |

| Recommended action | Refurbish |
