# Structural Inspection Checklist

| Site | Kennet House, Reading |

| Project | Kennet House, Reading: structural inspection (completed example) |

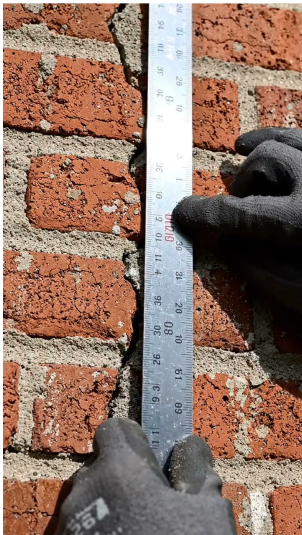
| Reference | S2 |

| What was seen | Cracking |
| Location | North gable, ground floor, 2 m from the front corner |
| Crack width at the widest point | 1 |
| Crack length | 900 |
| Description | Fine crack through the bricks and mortar, even width, no displacement across it. Pointing in the crack looks old. |

| What should be done | Fit a tell-tale and read it monthly for six months. |

| Action | Fit a tell-tale on crack S2 and read it monthly for six months. |

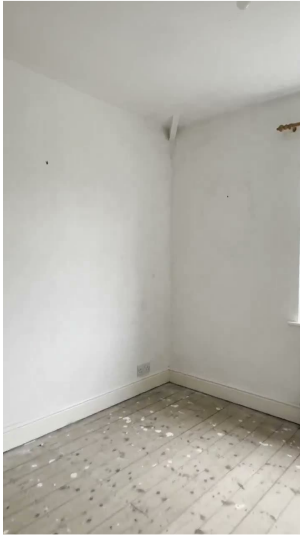
| Reference | S3 |

| What was seen | Deflection or sagging |
| Location | Rear office 1.04, middle of the room, under the former partition line |
| Deflection measured at the worst point | 28 |
| Span divided by deflection | 150 |
| Description | Floor dips towards the middle of the room and bounces when walked on. String line across the span shows 28 mm at the worst point. A partition shown on the 1998 plans has been removed above this floor. |

| What should be done | Lift boards along the dip to check joist size, notching for cables and the bearings, then decide on strengthening. |

| What each investigation should find out | Open up the first floor in office 1.04 to record joist size, spacing, notches and bearings, then check the joists with the current layout. Tell-tale on the north gable crack S2. |

| Action | Open up the floor in office 1.04 and send joist sizes and photos to the engineer for a check. |
