# Temporary Works Inspection

| Project | Lowfield Green, Doncaster: slab edge protection (completed example) |

| Temporary works register item and location | TW-C-11, tube and fitting edge protection to the Block C first floor slab edge |
| Approved drawing and revision | Edge protection layout TW-C-11 rev B |

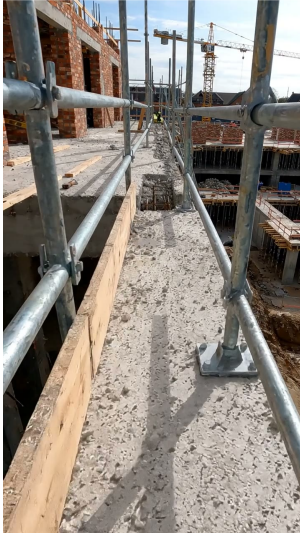
**Inspection evidence**

| Action, limitation or reason not applicable | Toe board missing for about 3 m beside the open ground beam trench at grid 4. Replaced before work resumed on that edge. |

**Action, limitation or reason not applicable** One base plate moved by the groundworks gang to reach the trench. Reset to the layout and the gang reminded not to alter edge protection.

| Departures and designer/coordinator referral | Base plate moved from the TW-C-11 rev B position at grid 4. Reset to the drawing; no design change needed. Reported to the temporary works coordinator. |

| Action and evidence reference | Replace missing toe board at grid 4 |
| Completion evidence | Fitted and seen at 15:10 reinspection. |
