# Thermal Imaging Survey

| Prepared for | Ribbleton Cold Stores Ltd |
| Date | 24 Sep 2026 |

| Project | Ribbleton Cold Stores, Preston: switchroom thermal imaging survey |

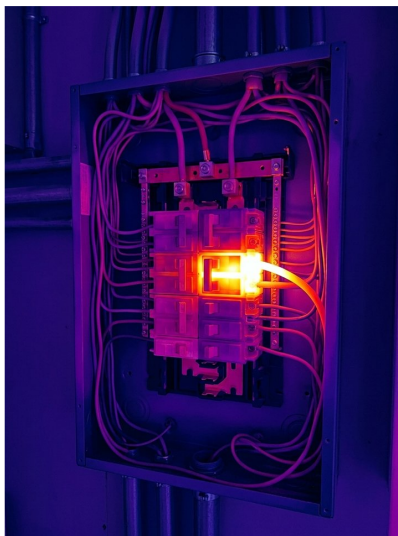
**Thermal observation 2: DB-3 (compressor feeds), way 4, L2 cable termination**

| Asset or location | DB-3 (compressor feeds), way 4, L2 cable termination |
| Measured temperatures, units and comparison point | 68 °C on L2, compared with 41 °C on L1 and L3 of the same circuit |
| Interpretation, basis and uncertainty | 27 °C above the other phases on the same circuit. Pattern suggests a high-resistance connection at the L2 termination. Load balance not confirmed with a clamp meter and bare metal not measured because of low emissivity. |

| Confirmatory testing or specialist investigation | Electrician to isolate DB-3 way 4, check and re-terminate L2, then rescan under similar load. |

##### Further action 1: Isolate DB-3 way 4, check the L2 termination and remake it. Job RCS-E-0927.

| Completion evidence | L2 lug found loose and remade under isolation on 30 September. Job sheet RCS-E-0927. |

##### Further action 2: Rescan DB-3 way 4 under similar load to confirm the repair.
